10 PRINCIPLES OF FUTURE-PROOFING

...and the story of the
Arctic Building Walrus Heads

RICHAVEN PLLC

SUSTAINABLE PRESERVATION ARCHITECTURE & CONSTRUCTION MANAGEMENT

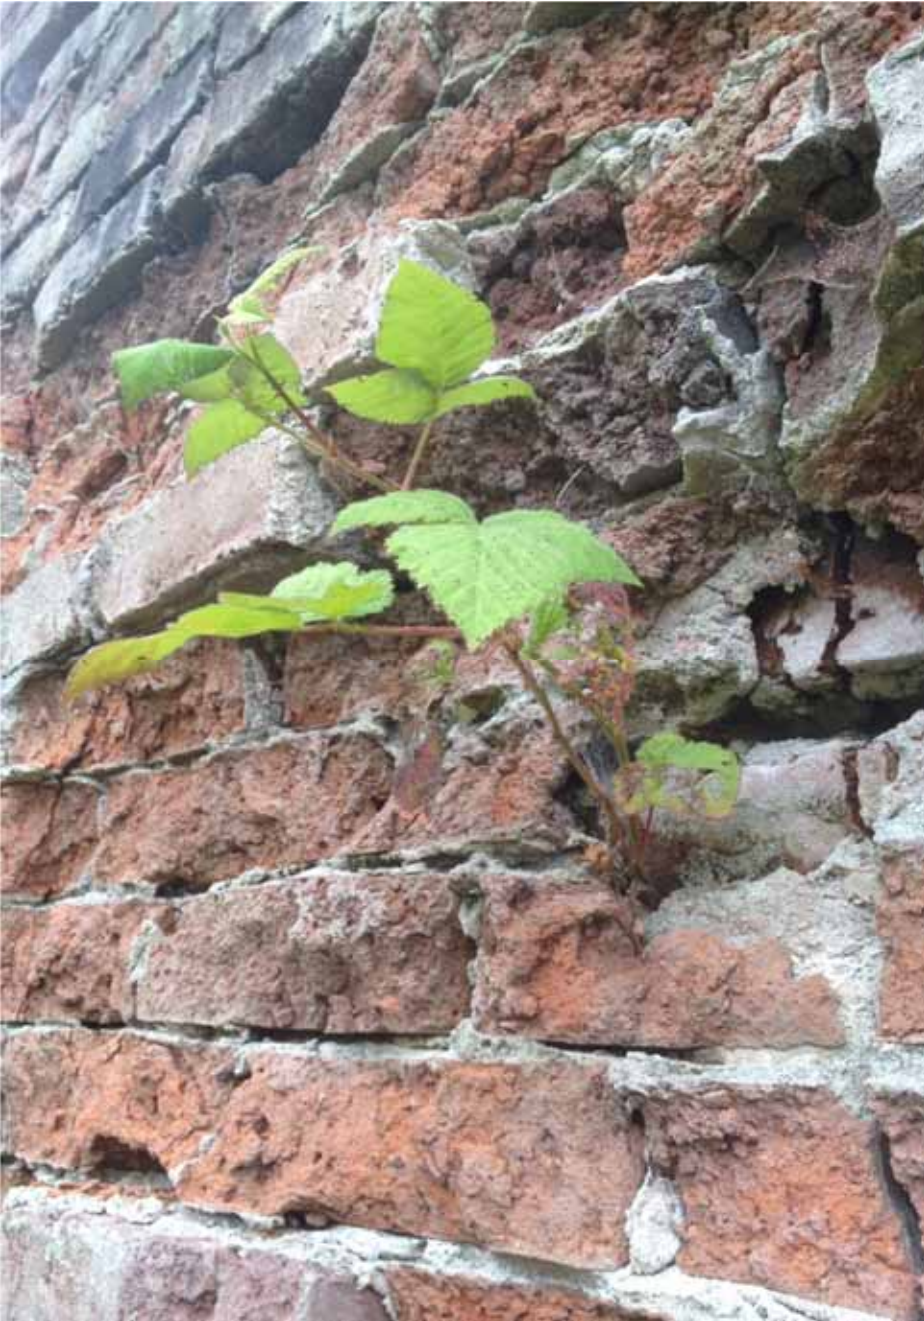
Figure 0: Brick and mortar deterioration at an exterior site wall. Credit: Brian Rich, 2013

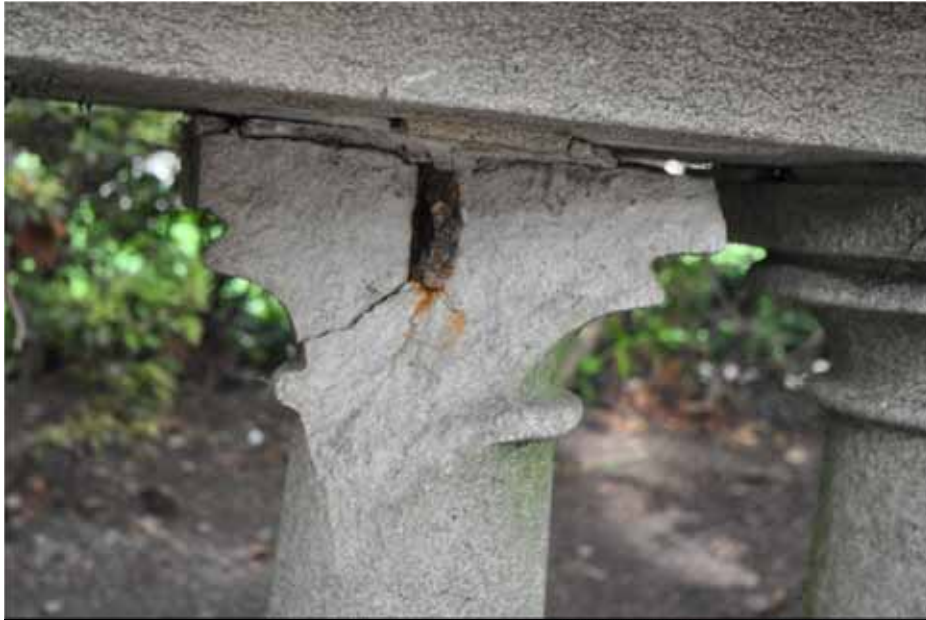
Figure 1: Spalled stone due to rust jacking at a railing. Credit: Brian Rich, 2013

- Mild steel pins used to anchor stone balustrades and railings rust and expand (“rust jacking”), splitting the stone and causing irreparable damage
- When re-pointing a masonry wall, using mortar that is harder than the brick traps moisture in the brick. Freeze-thaw cycles cause the brick to spall.
- Mortar is intended to be sacrificial – not the brick

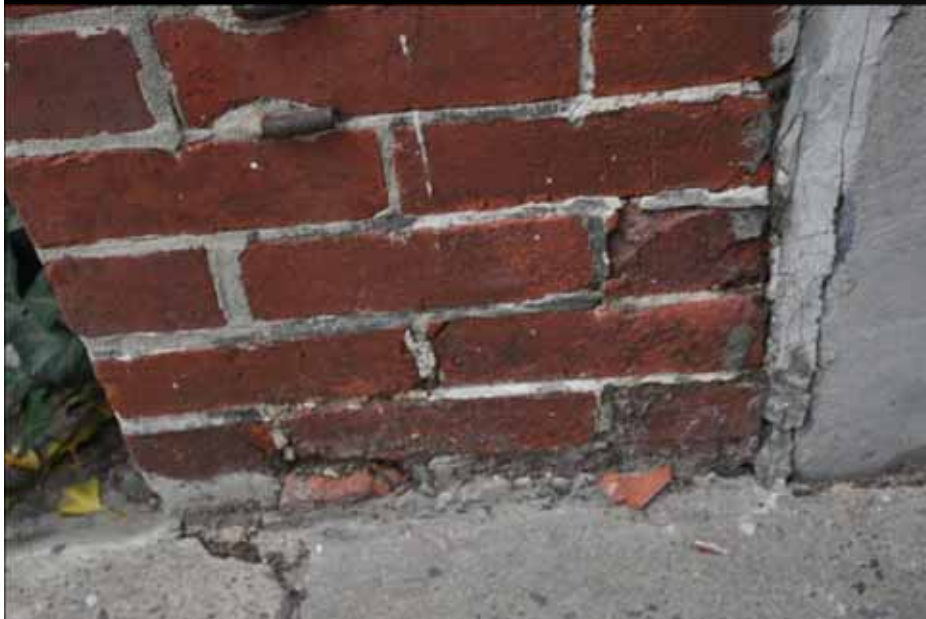
Figure 2: Brick spalling due to mortar installed that was harder than the brick. Credit: Brian Rich, 2013

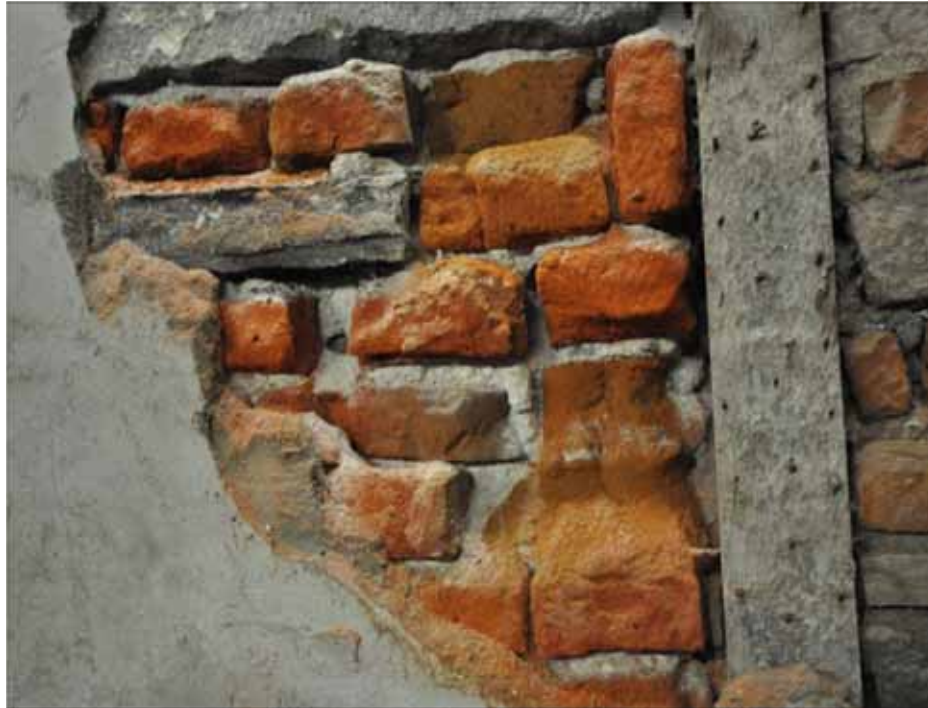
Figure 3: Deteriorating brick, mortar and plaster at the barracks at La Citadelle de Quebec. Credit: Brian Rich, 2014

- Constant exposure to water and extreme freeze thaw cycles for decades is harsh on brick, mortar, and plaster – no matter how hard it is!
- When designed and built to prevent air infiltration, trapped water vapor can cause Sick Building Syndrome, including severe mold attack

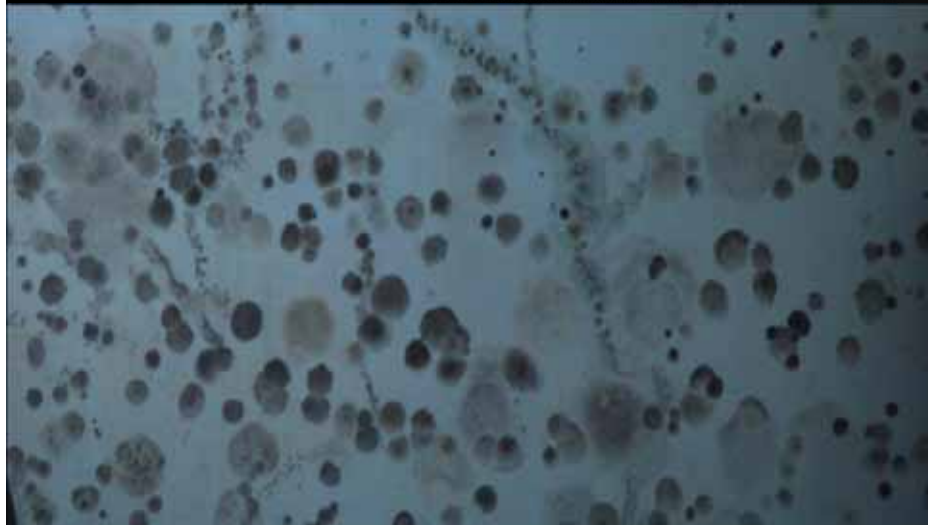
Figure 4: Mold caused by too much water vapor trapped within a building. Credit: http://media.kmvt.com/images/MOLD1.jpg_BIM.jpg

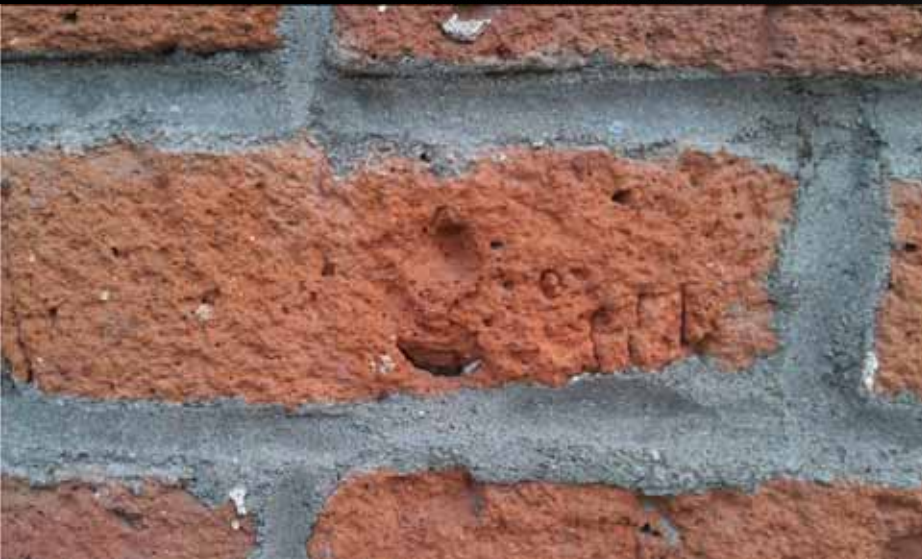
Figure 6: Sandblasted brick removes the fire skin from the brick. Credit: <http://www.permies.com>

- Incorrectly installed siding and weather barriers allow water penetration and lead to structural deterioration.
- Sandblasting and power washing brick removes the protective fire skin from its surface making it more vulnerable to deterioration

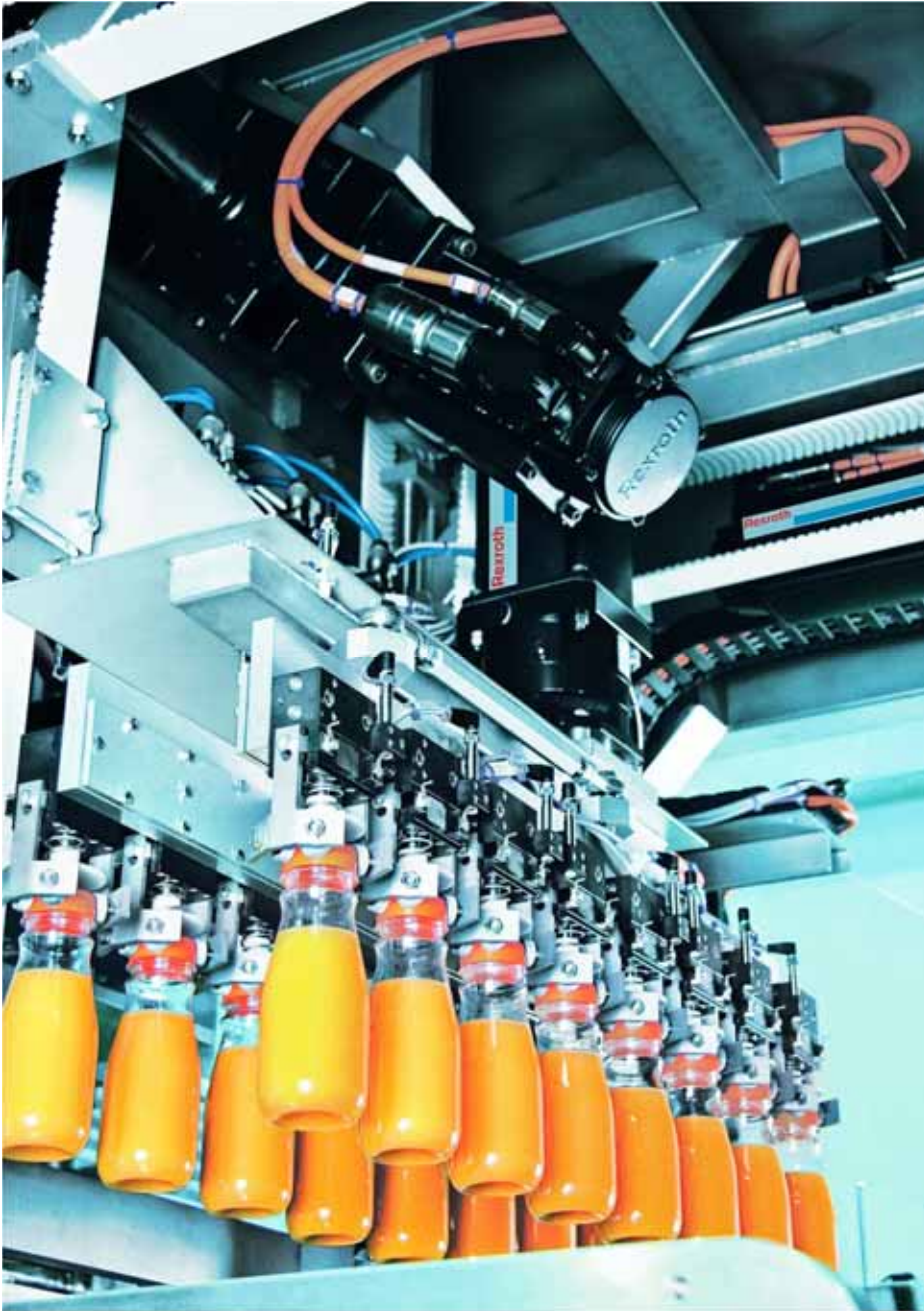
Figure 10: SERCOS – a future-proof standard: Broader, deeper, more universal. Credit: <http://www.boschrexroth.com>

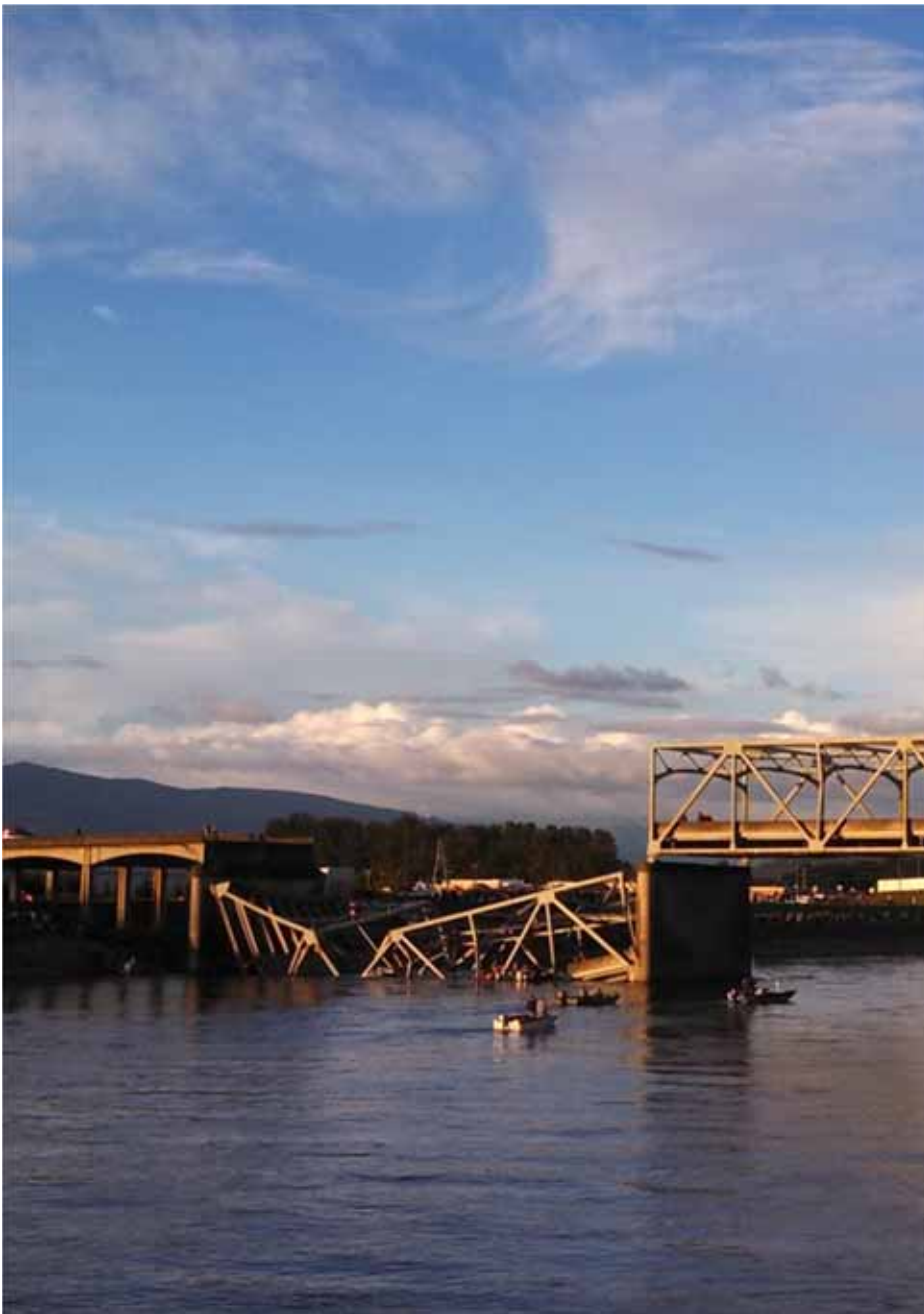
Figure 14: The collapsed I-5 bridge at the Skagit River was “functionally obsolete.” Credit: http://en.wikipedia.org/wiki/File:05-23-13_Skagit_Bridge_Collapse.jpg

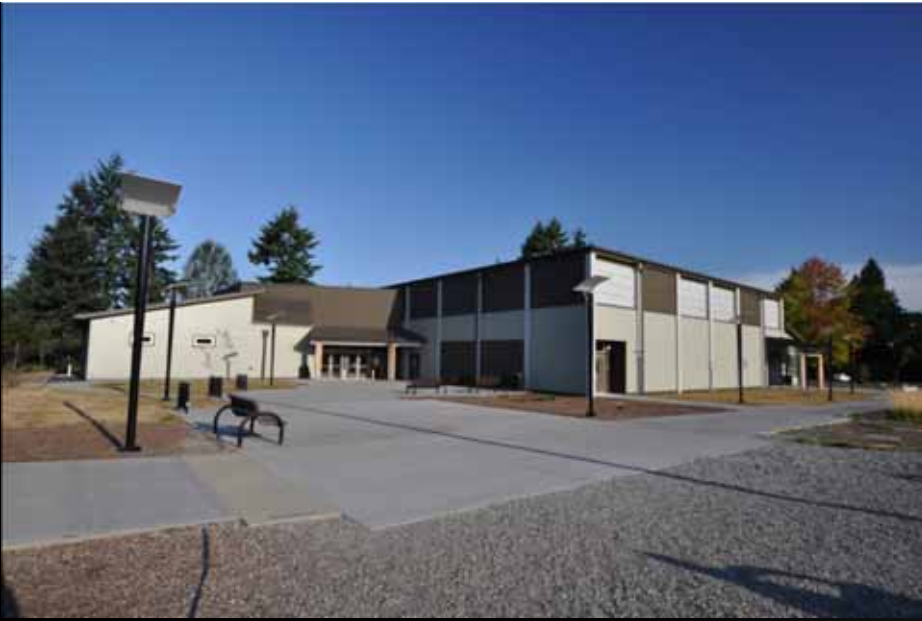
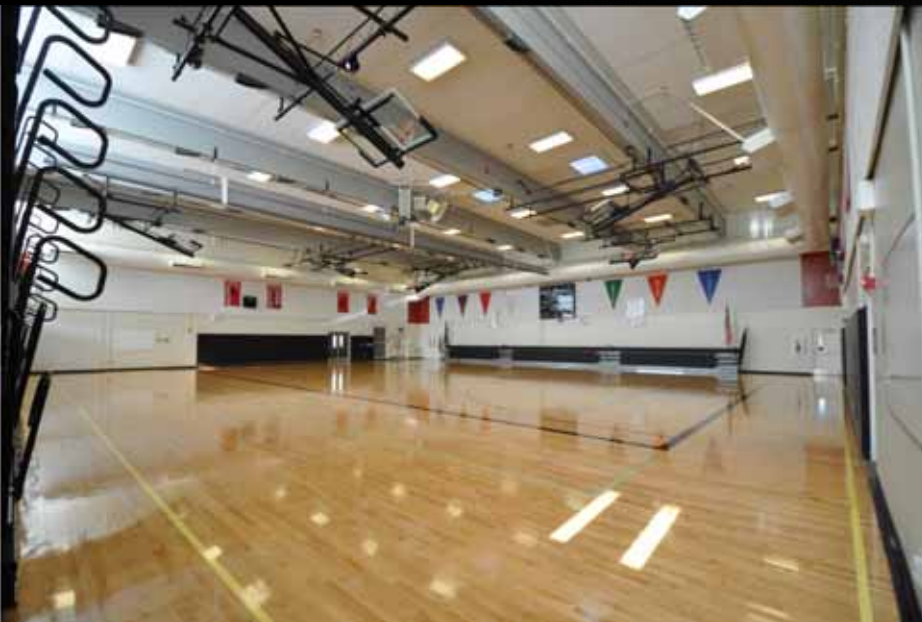
Figure 22 & 23: Exterior and Interior of the Lakota Middle School Gym, Federal Way, WA. Credit: Brian Rich, 2013

Project concept is to compare 4 gyms of different design for 200 year life spans to attempt to answer these questions:

1. (1) 12,150 SF MS Gym
2. Not functionally equivalent due to maintenance and replacement of materials.

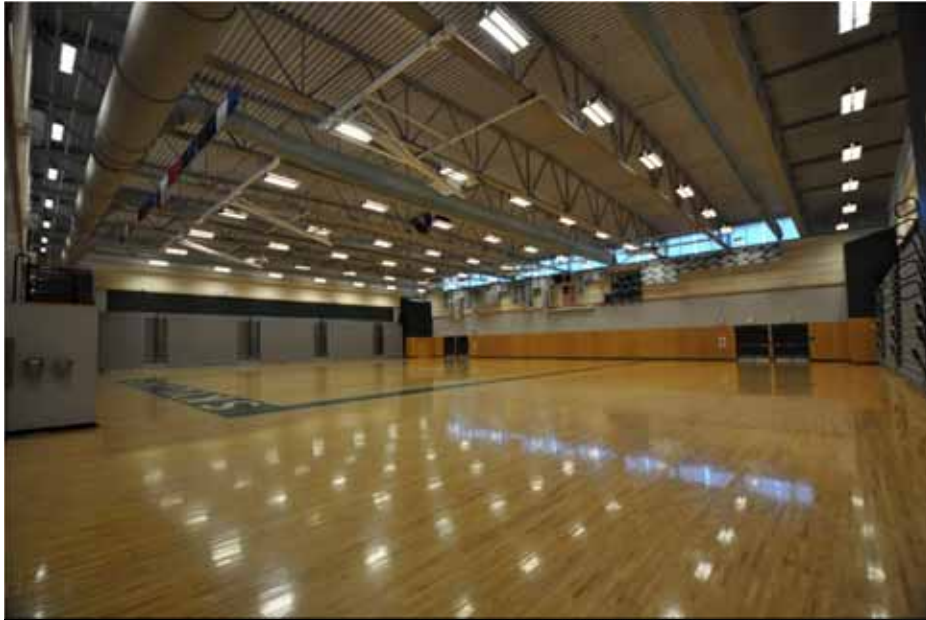
Figure 24: Skyline High School Gym, 2013. Credit: Brian Rich, 2013

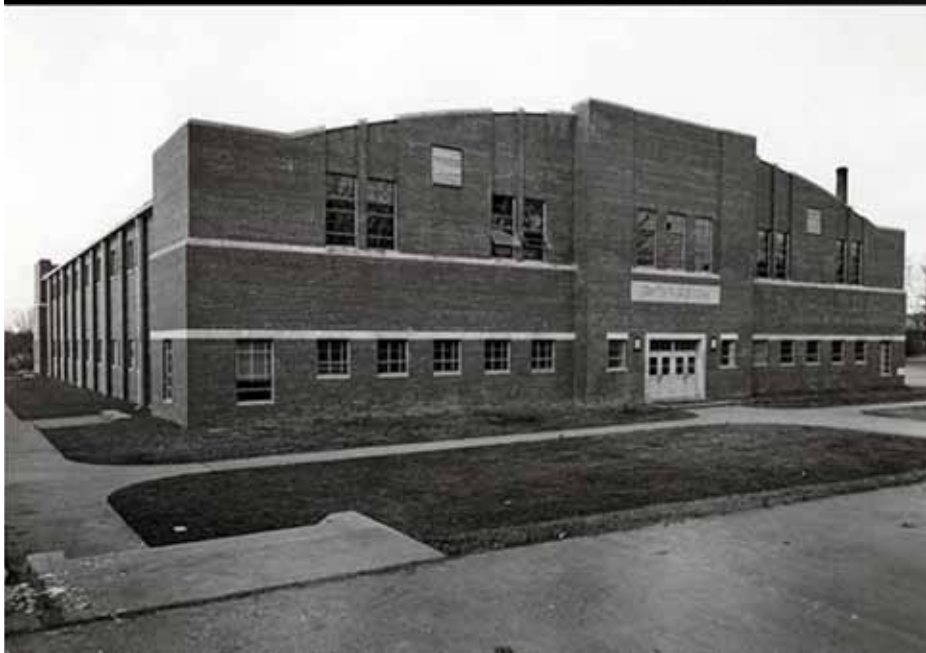
Figure 25: Elon University Gym, 1950. Credit: <http://www.elon.edu>

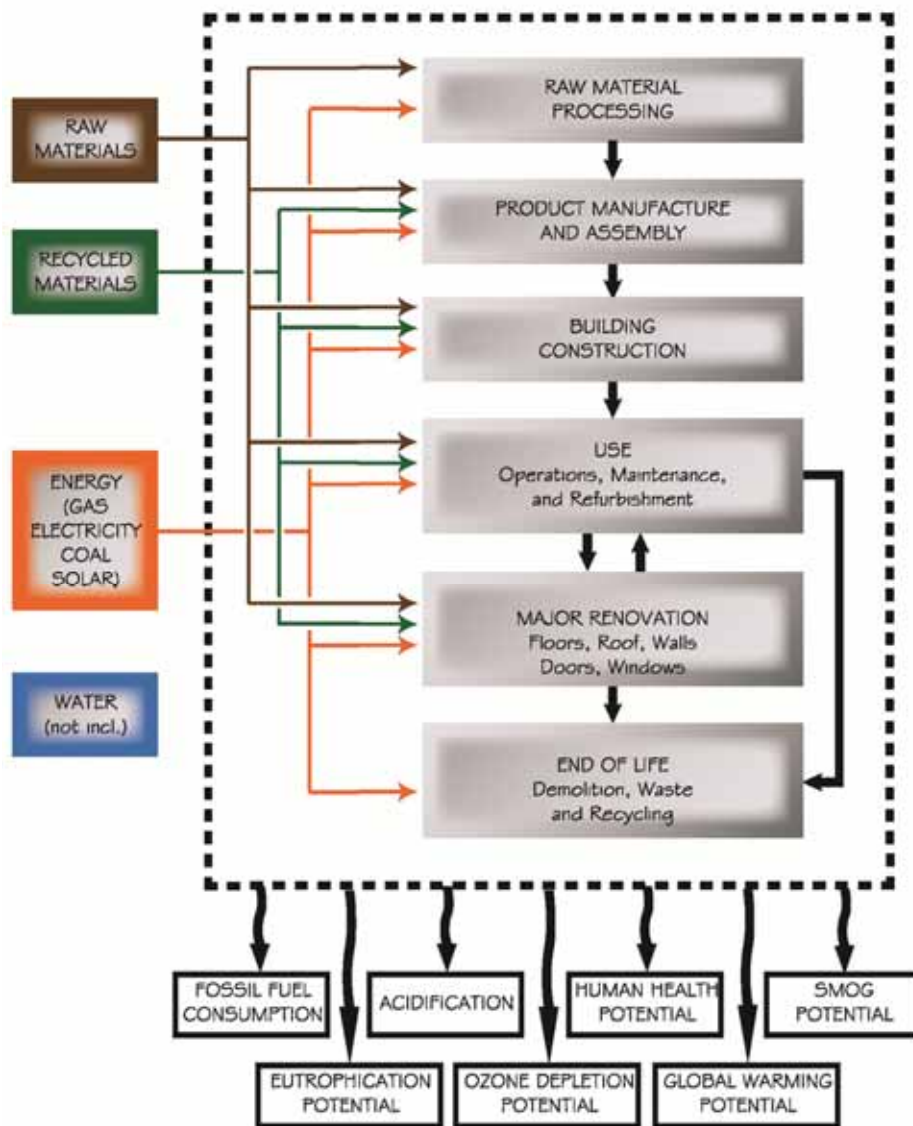
LIFE CYCLE ANALYSIS DIAGRAM - MIDDLE SCHOOL GYMNASIUM
Brian Rich - Arch 598 LCA - May 05, 2014

1. The LCA system diagram illustrates the default processes that are included by Athena in this analysis.
2. Water use is not included
3. Impacts are measures in summary impacts rather than raw data.

Figure 26: Life Cycle Analysis System Diagram. Credit: Brian Rich, 2014

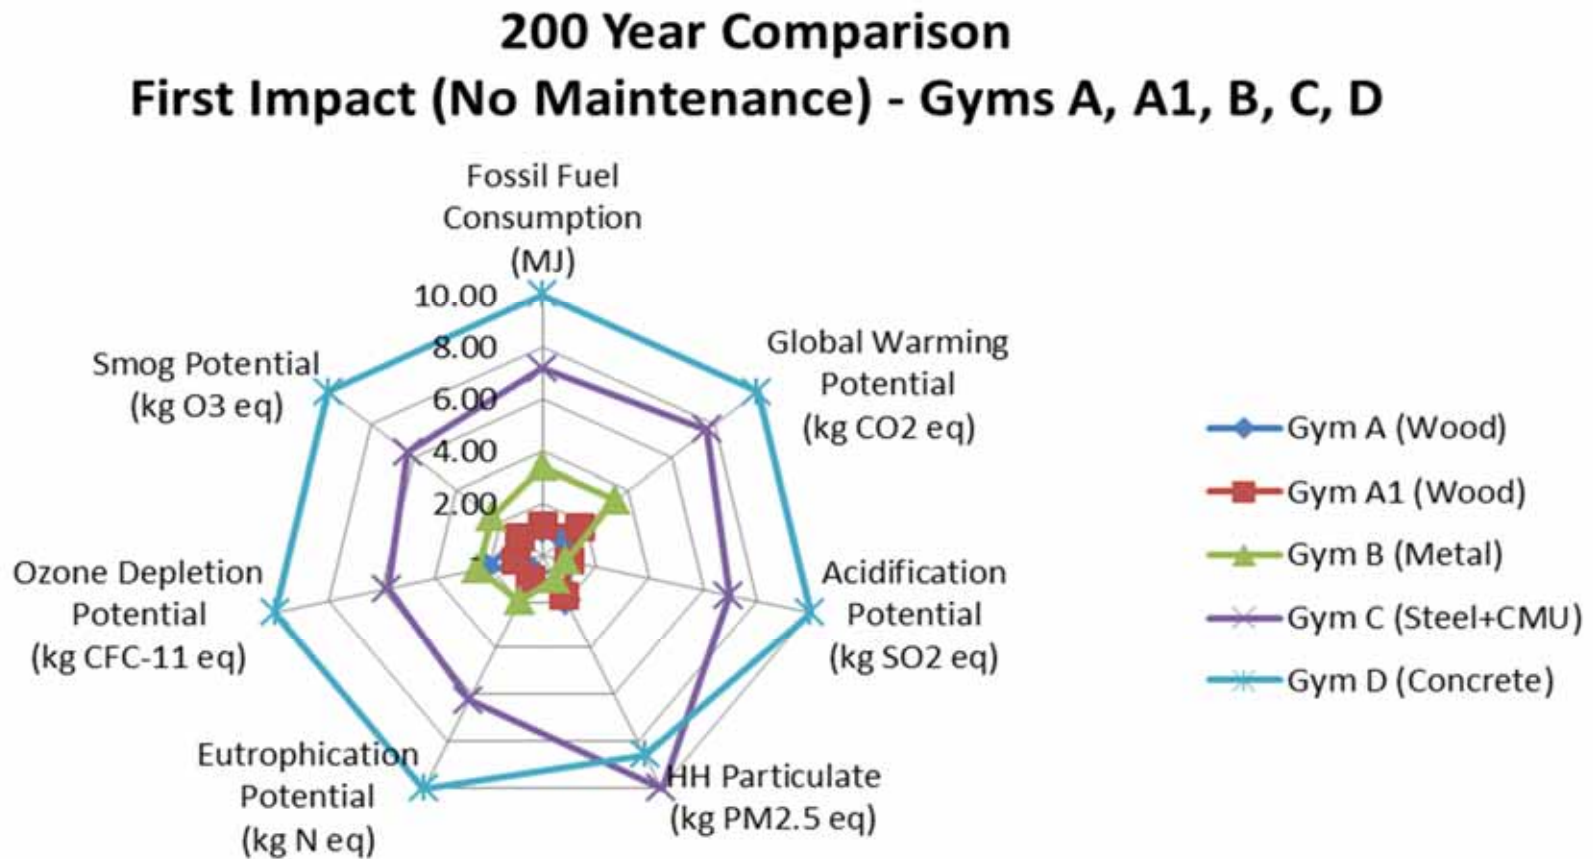
Figure 28: First Impact Comparison, normalized on a scale of 10. Note that the buildings involving masonry and concrete (Gym C and D) have the most significant first impacts and wood (A and A1) the least. Credit: Brian Rich, 2014.

1. The concept of “First Impacts” is introduced in this Life Cycle Analysis
2. Wood structures appear to have the lowest short term and long term environmental impacts, regardless of how biogenic carbon is accounted for
3. More durable CMU, structural steel, concrete, and brick materials pay off when ongoing maintenance is compared to wood structure replacements.
4. Biogenic carbon only affects Global Warming Potential and is eventually released (and thus non-beneficial) if the service life under consideration is approximately 200 years. Biogenic carbon sequestering is a good short term CO2 reduction strategy – if more trees are planted.

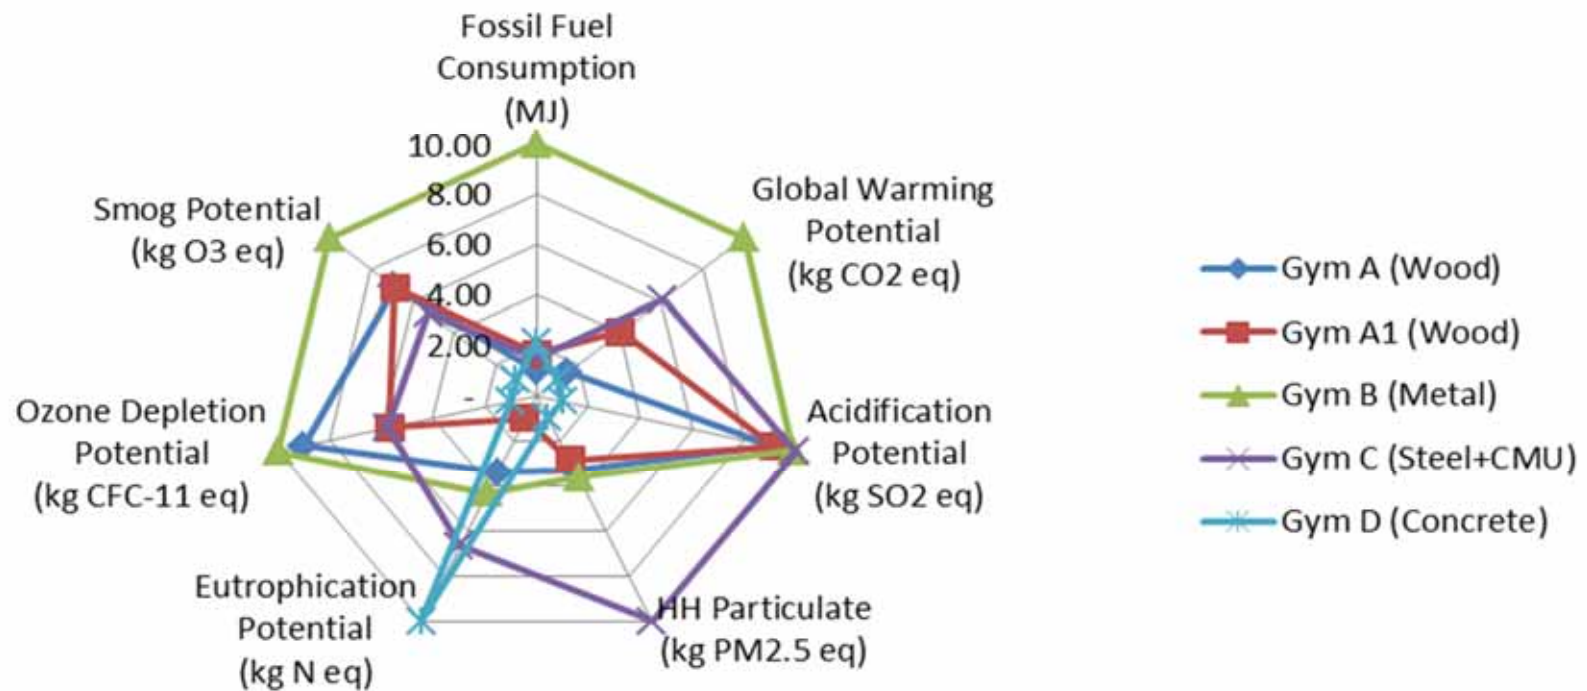
200 Year Comparison Maintenance of Existing Gyms (No First Impact)

Figure 29: 200 year comparison of maintenance requirements, not including first impacts, normalized on a scale of 10. Note that the Gym D has the least maintenance impact in most categories and Gym B has the largest impacts in most categories. Credit: Brian Rich, 2014.

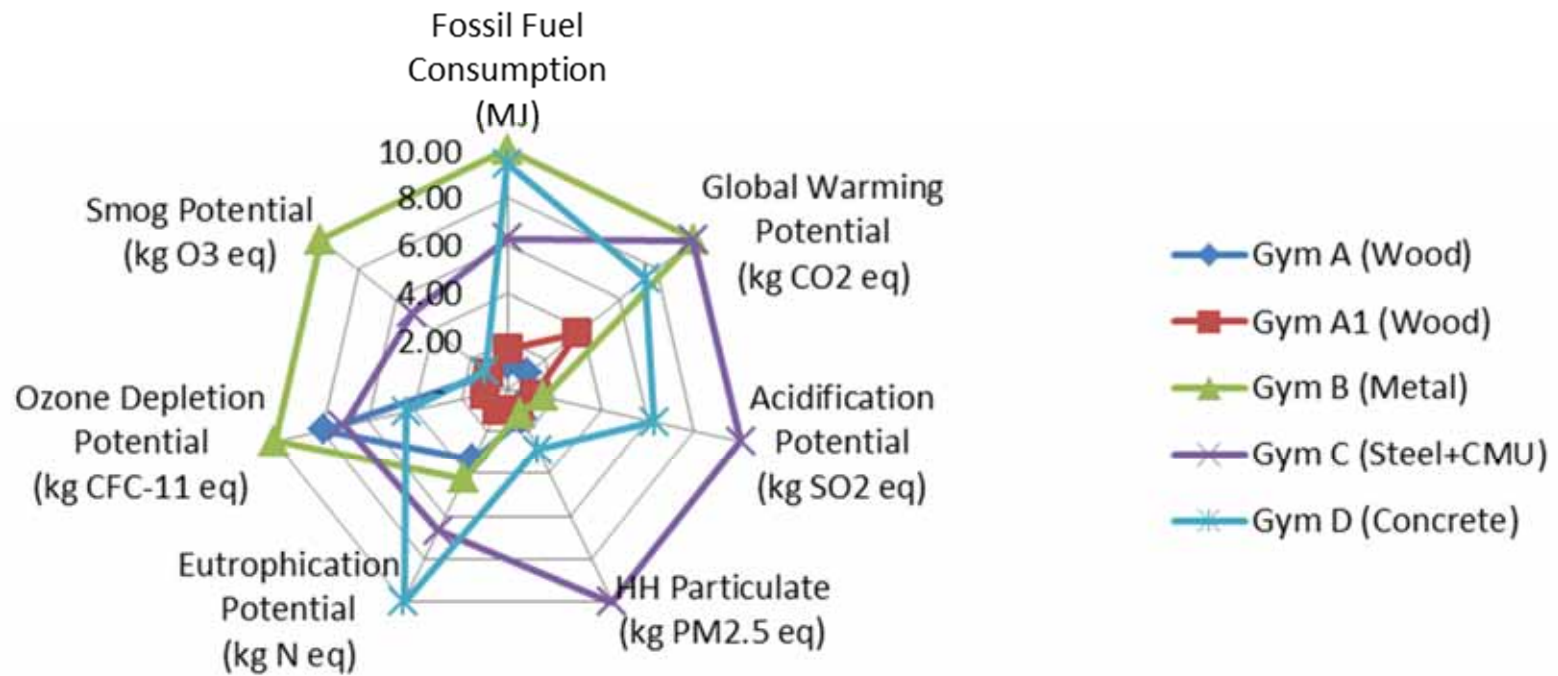
200 Year Comparison Total Impacts of New Construction

Figure 30: 200 year comparison of total environmental impacts including first impacts and maintenance, normalized on a scale of 10. Gym B and C typically have the largest impacts while Gym D has mixed total impacts and Gym A and A1 the least total impacts. Credit: Brian Rich, 2014.

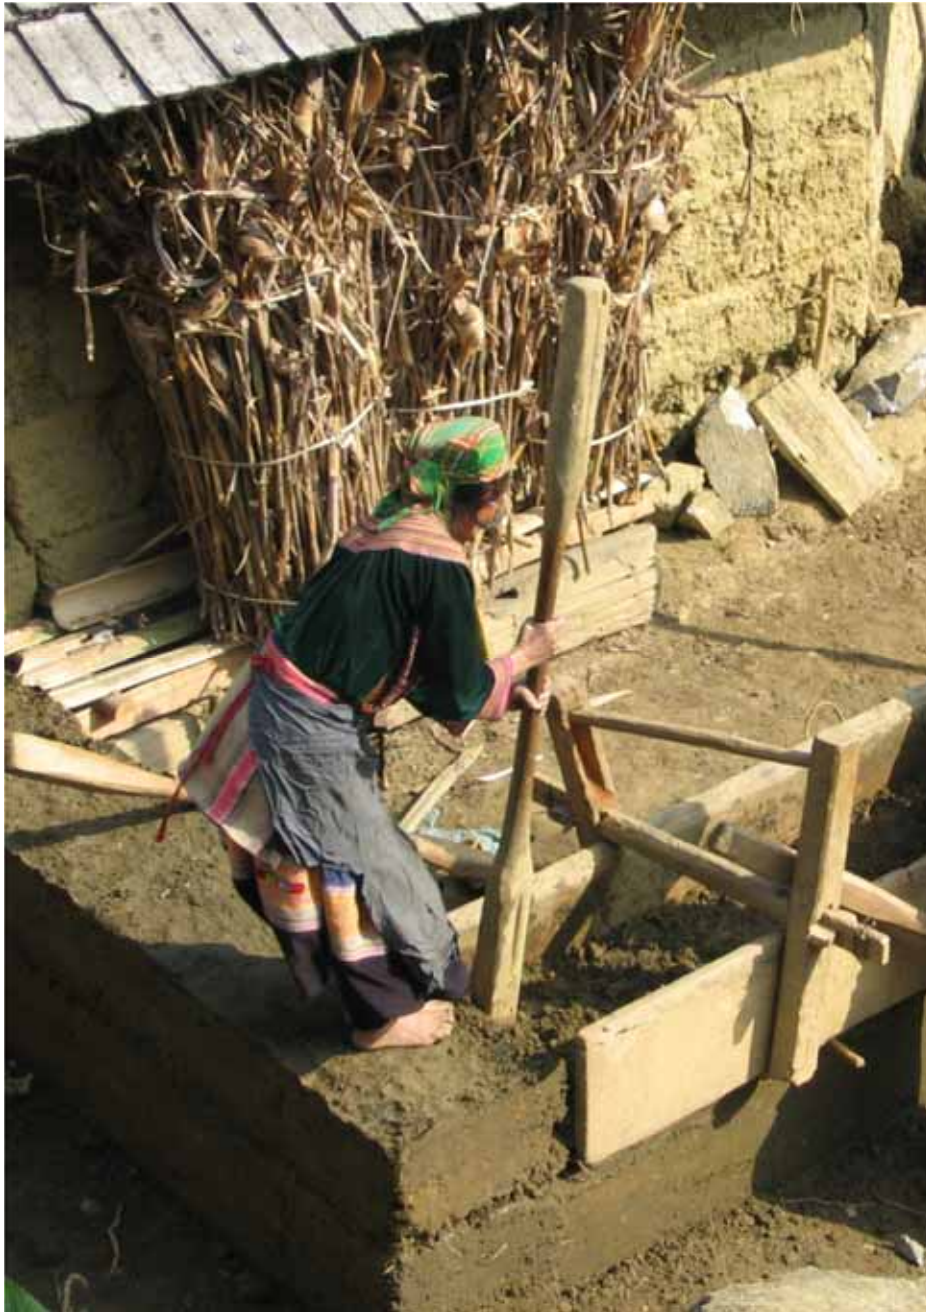
Figure 32: A typical Hmong house-building technique in the tropical climate of Vietnam. Credit: http://en.wikipedia.org/wiki/Rammed_earth

- Rammed Earth
- Bamboo
- Mud Brick
- Straw Bale
- Adobe
- Thatch
- Reeds
- Wood
- Stone

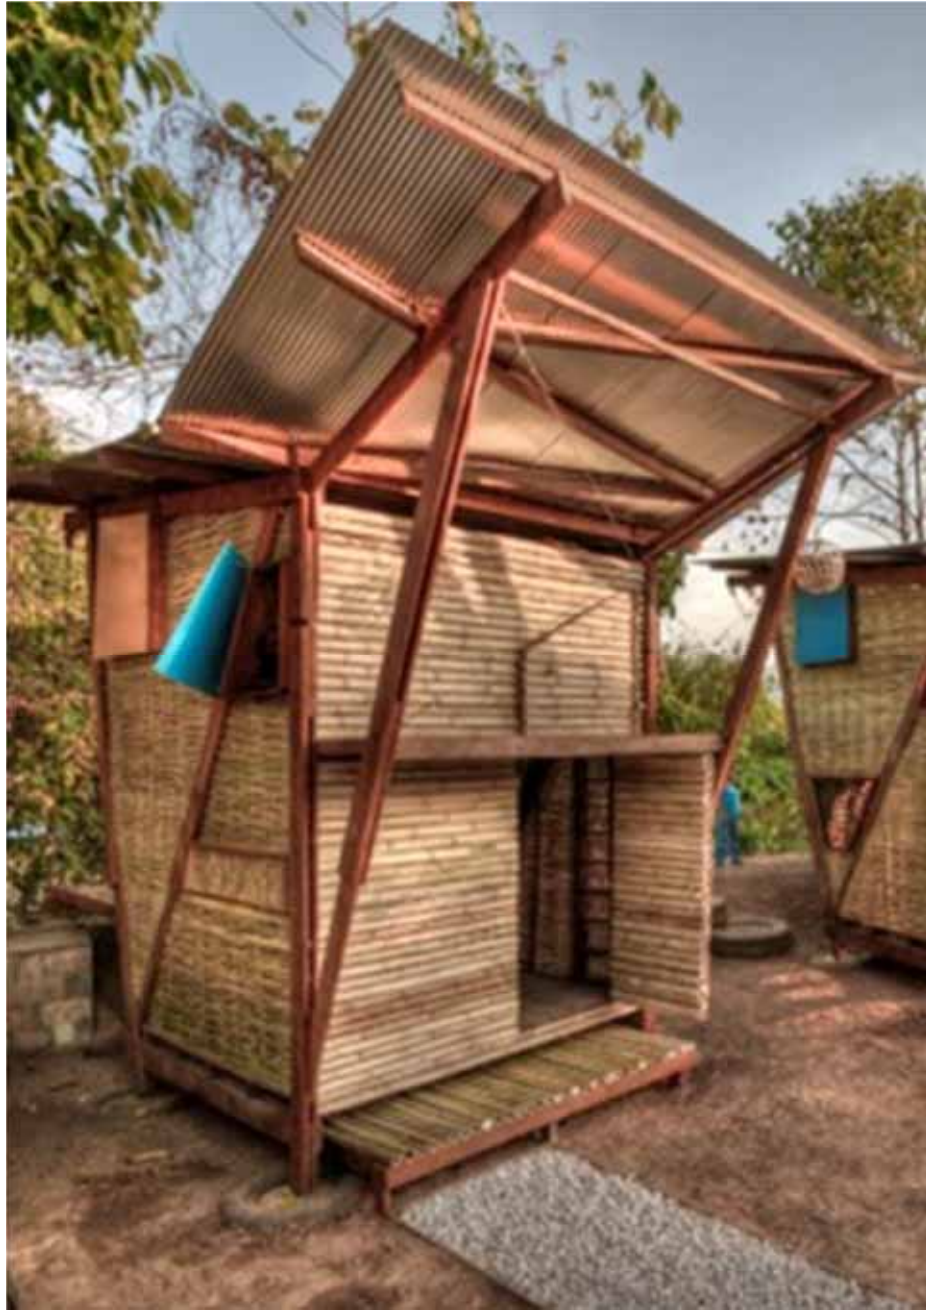
- Service life of TBM&M varies, but can usually be extended easily through maintenance and repairs when used in appropriate climates and designs
- Less technologically dependent materials are often more future-proof
- Future-proof building methods are not necessarily low cost when they are employed in developed regions
- Hybrid building systems take the best of both TBM&M and industrialized materials
- Environmentally responsive building design is critical to making TBM&M work in each region
- Intent of future-proofing is not to prevent use of manufactured materials

Figure 36: Soe Ker Tie House, Noh Bo, Tak, Thailand. Credit: Photo: Pasi Aalto / Tyin Tegnestue

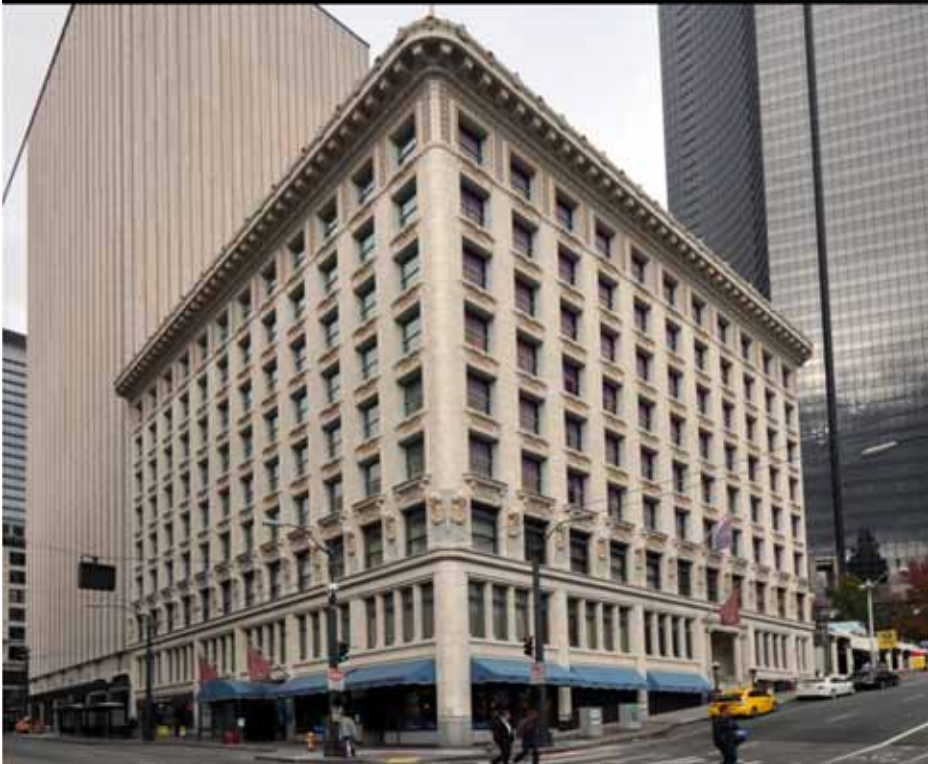
Figure 40: The Third Ave and Cherry Street corner of the Arctic Building. Credit: Brian Rich, 2013

- Designed and built in 1917
- Originally the home of the Arctic Club
- Finest example of a multi-colored matte glazed decorative terra-cotta building in the Northwest
- Original use as offices for the Club, leasable offices, private rooms, and flexibility for the tenants
- Adaptively used through the mid-20th century as offices for the City of Seattle
- Sold to the City of Seattle in 1988

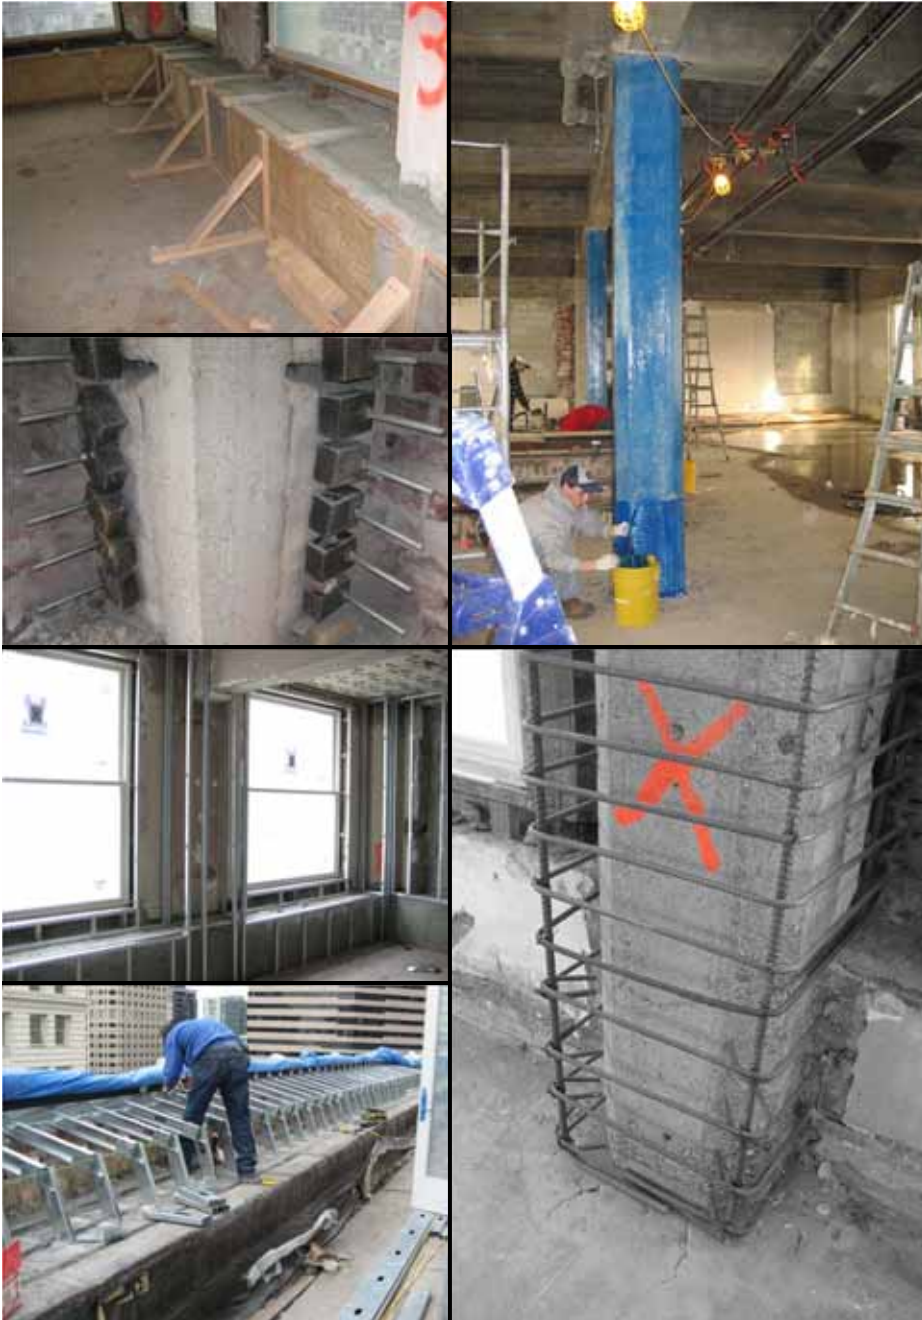
- Complete seismic retrofit
- Restoration of interior details and finishes
- Very little exterior work except anchoring of parapet
- Complete window replacement

Figure 43: 2005 Rehabilitation of the Arctic Hotel. Credit: Weaver Architects, 2005.

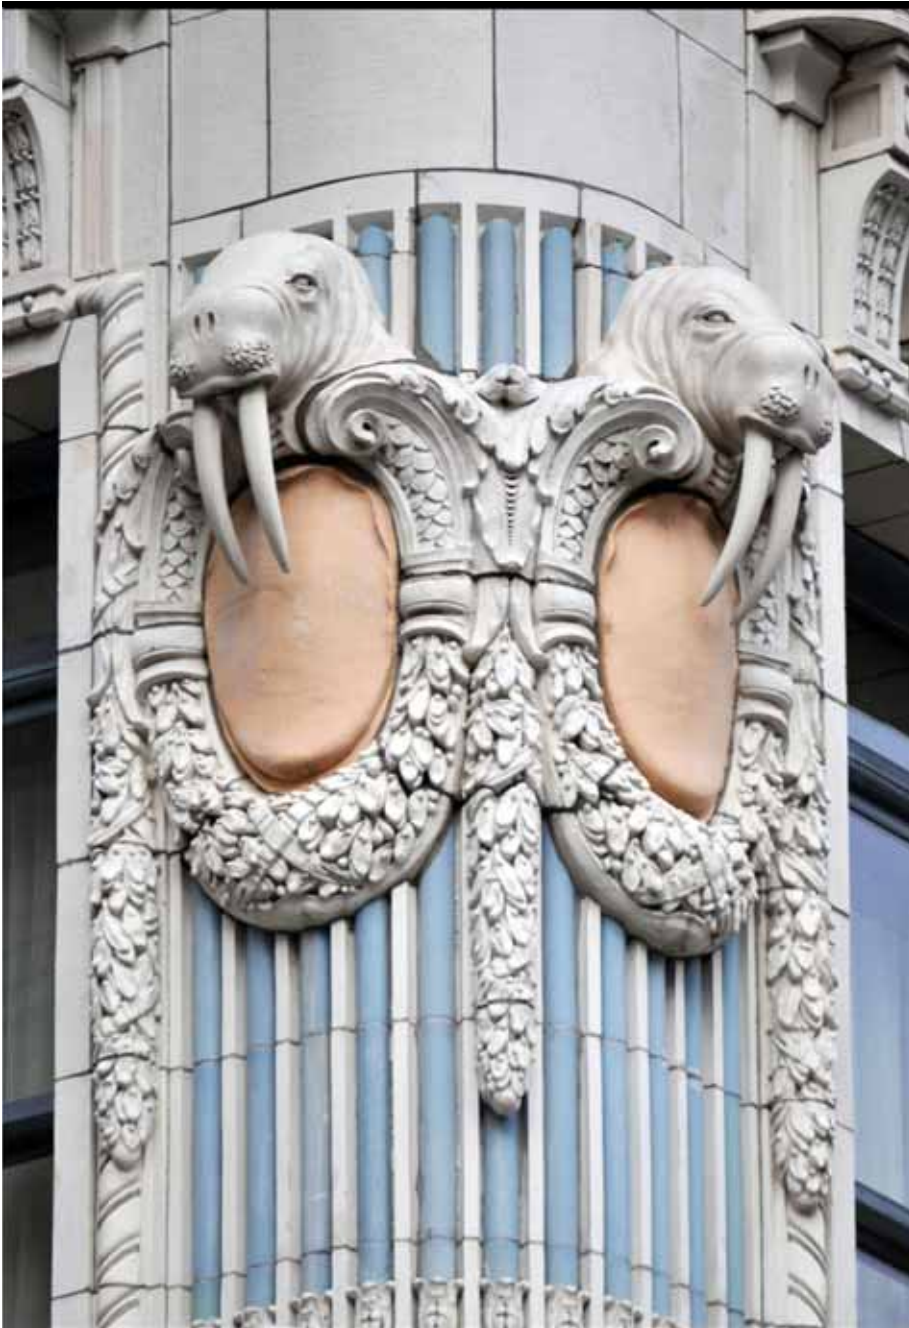
Figure 44: The double walrus head at the corner of the Arctic Building, Seattle, WA. Credit: Brian Rich, 2013

- Walrus heads decorate the Third Floor frieze
- Walrus tusks held in place with mild steel reinforcement
- Corrosion of the steel led to failure of the tusks in the 1970's and early 1980's

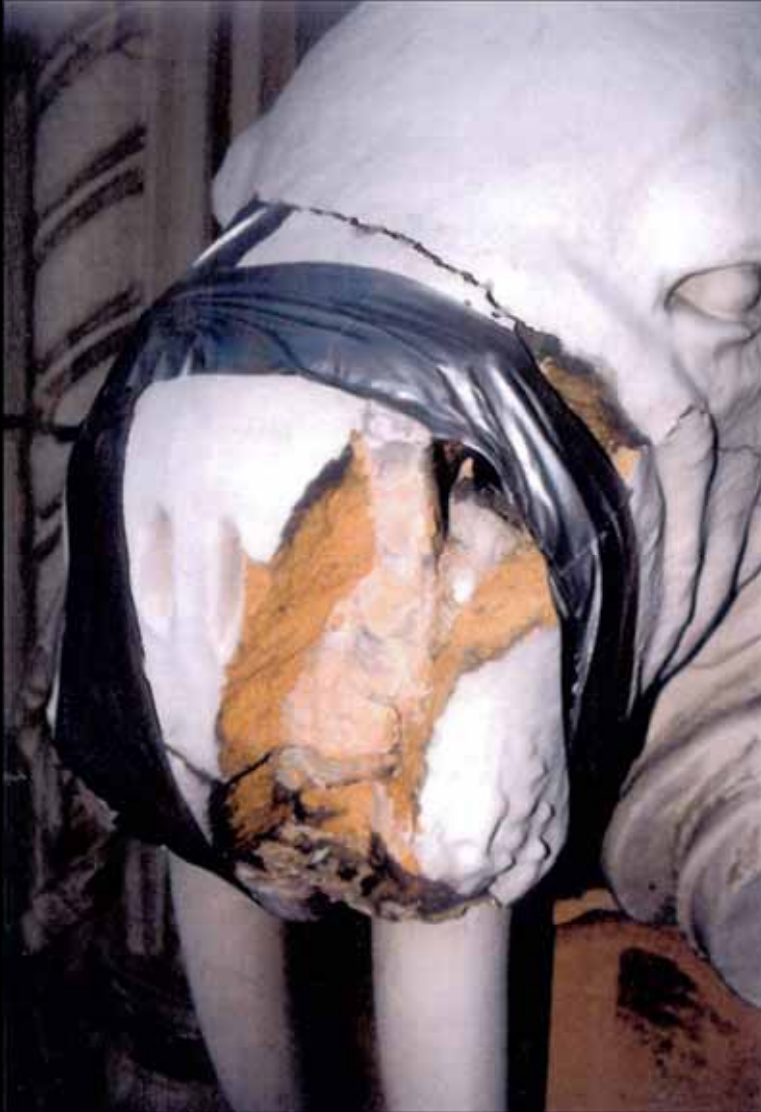
Figure 46: 1995 photo of the deteriorated walrus head at the Arctic Building. Credit: Wiss, Janney, Elstner, 1995.

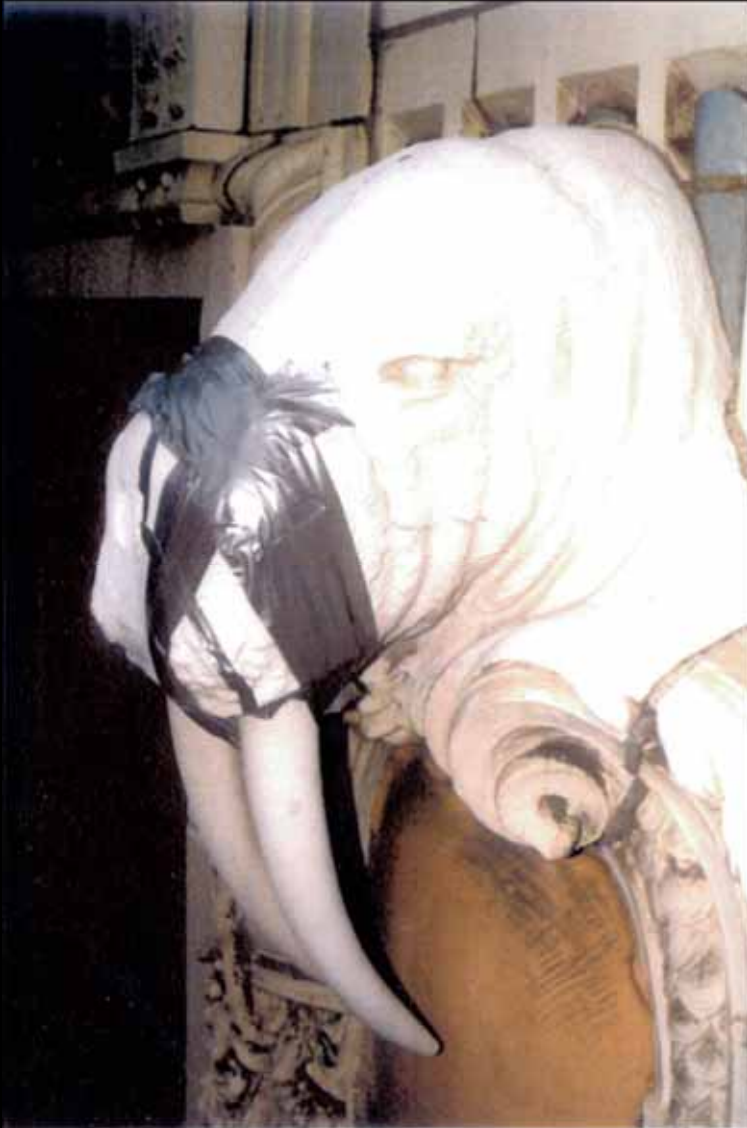
Figure 47: 1995 photo of the deteriorated walrus head at the Arctic Building. Credit: Wiss, Janney, Elstner, 1995.

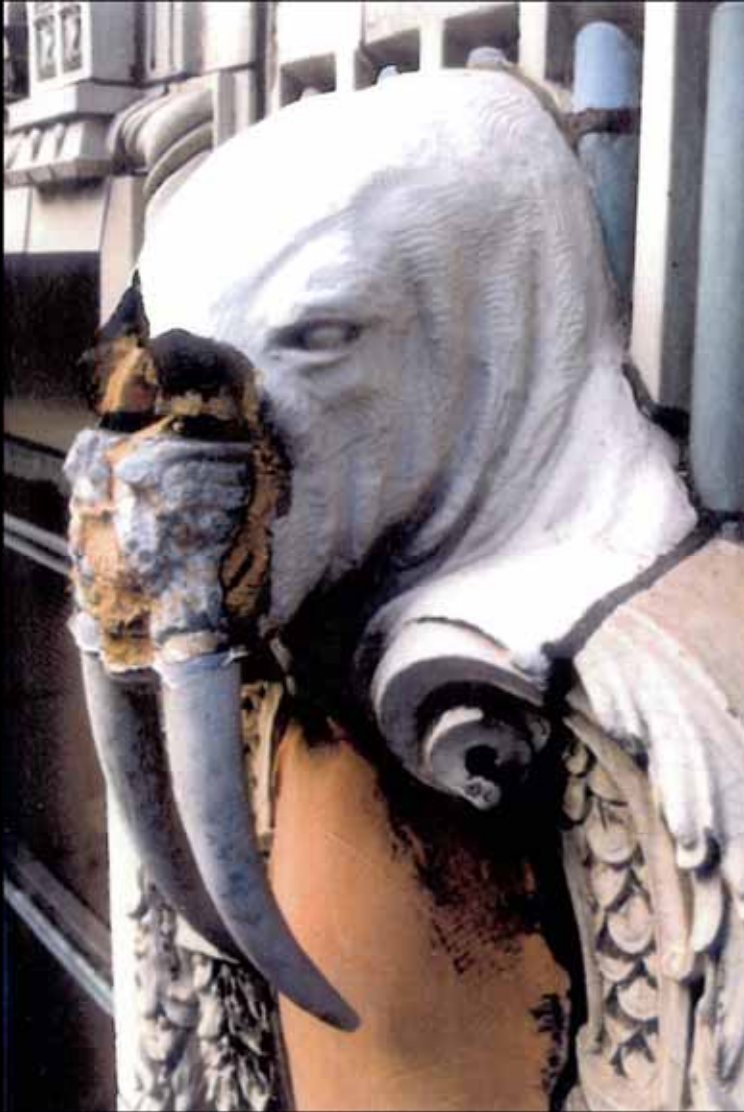
Figure 48: 1995 photo of the deteriorated walrus head at the Arctic Building. Credit: Wiss, Janney, Elstner, 1995.
