10 PRINCIPLES OF FUTURE-PROOFING

...and the story of the
Arctic Building Walrus Heads

RICHAVEN PLLC

SUSTAINABLE PRESERVATION ARCHITECTURE & CONSTRUCTION MANAGEMENT

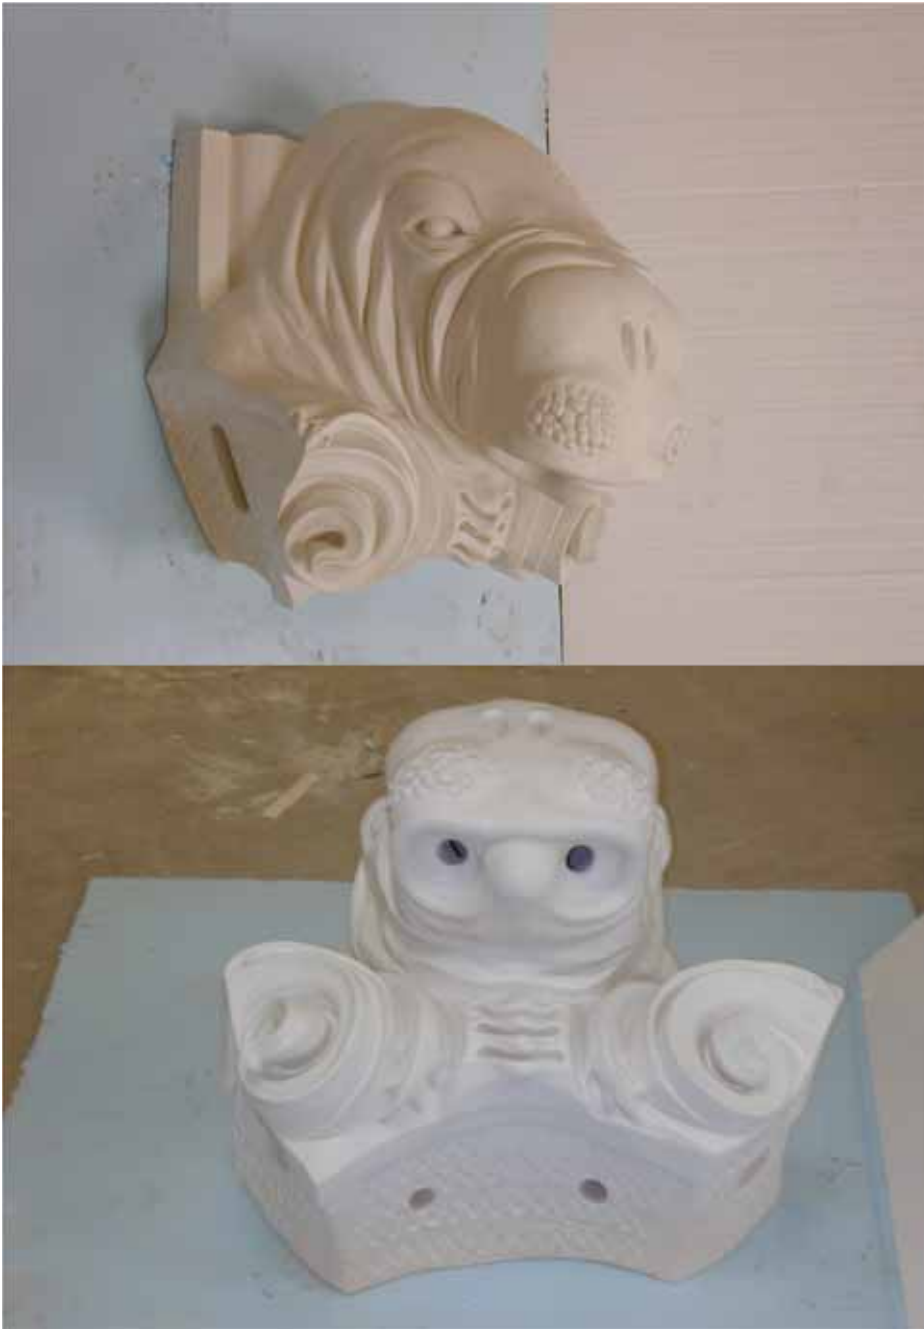
- One Walrus head was patched together enough to send back to Boston Valley terra Cotta
- A new mold was carved for new walrus heads
- The new mold was enlarged by about 10% to account for shrinkage of the new pieces during firing
- New pieces were glazed to match the original heads

Figure 50: New walrus head replacement pieces from Boston Valley terra Cotta. Credit: Boston Valley Terra Cotta, 1996.

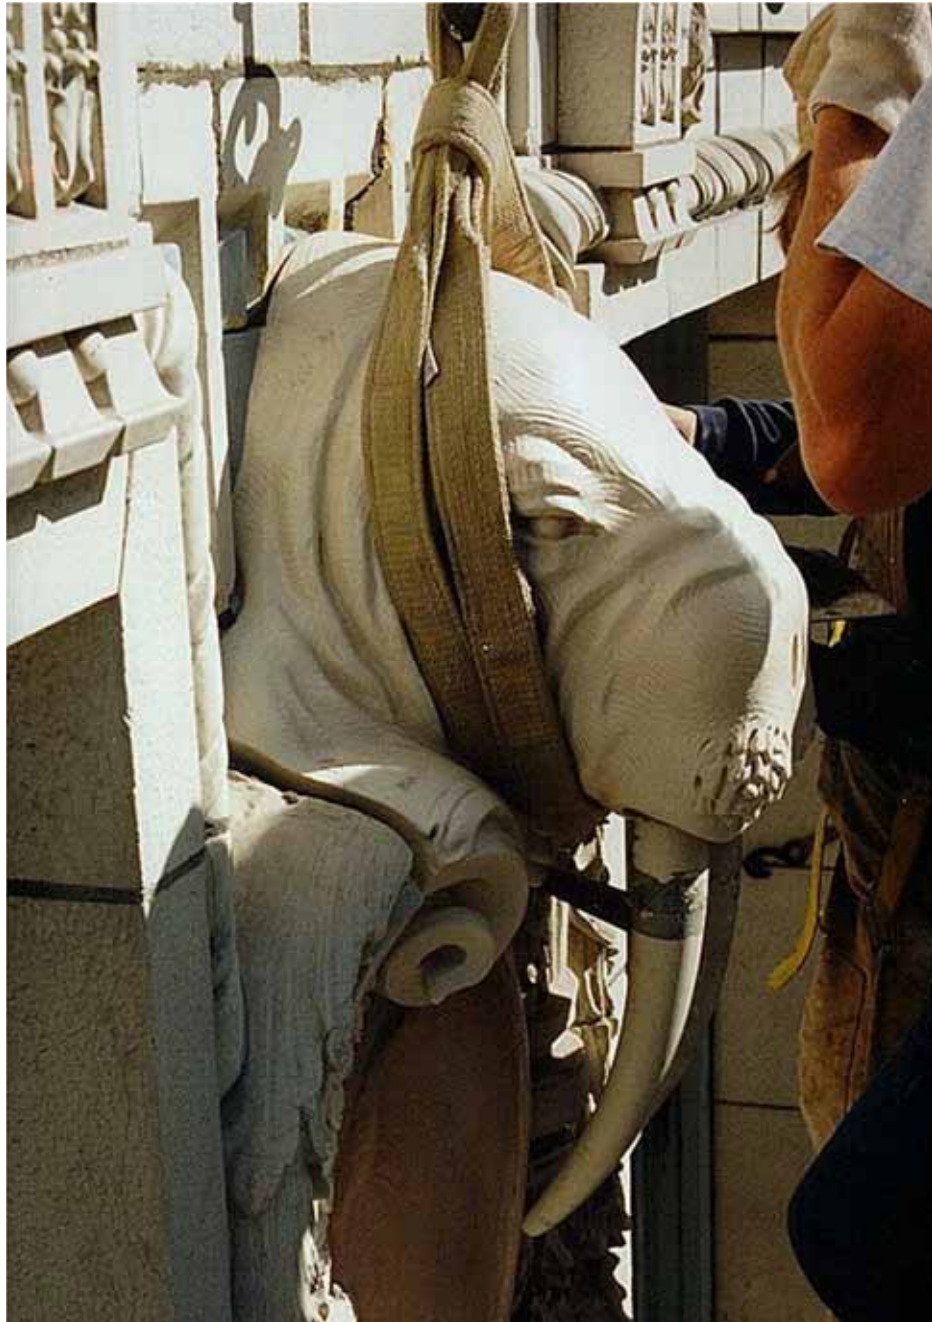
- 15 of the 27 walrus heads were replicated and replaced
- 7 additional heads were anchored together using helical pins
- Terra cotta repairs were crucial to maintaining the building envelope and historic appeal of the building for future investors
- The building was eventually sold to private investors and converted to a boutique hotel

Figure 51: Installation of a replacement terra cotta head. Credit: Wiss, Janney, Elstner, 1995
