Preservation of Modern Materials

27 April 2016

Brian Rich
APT_{NW} President

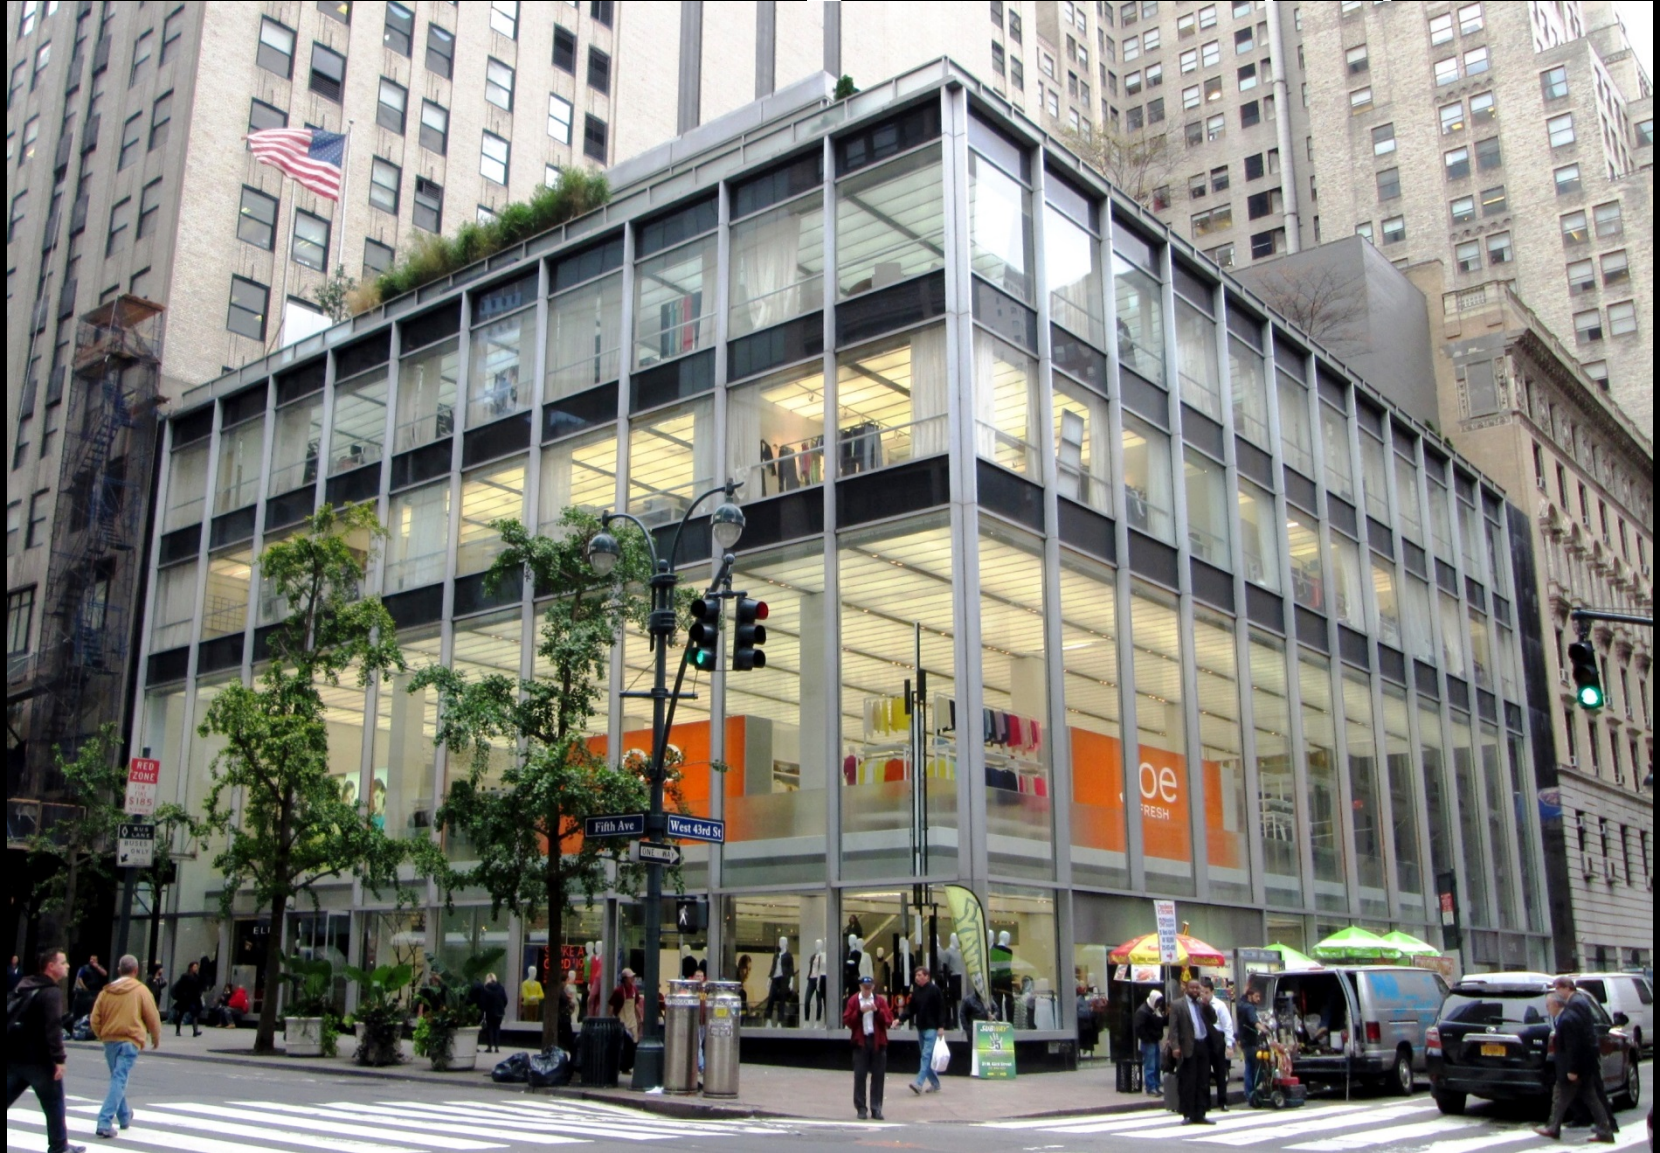
Figure __: The Manufacturers Trust Hanover Building in New York exemplifies the extension of the exterior envelope into the interior ceilings, floors, and walls. Credit: wikiwand.com

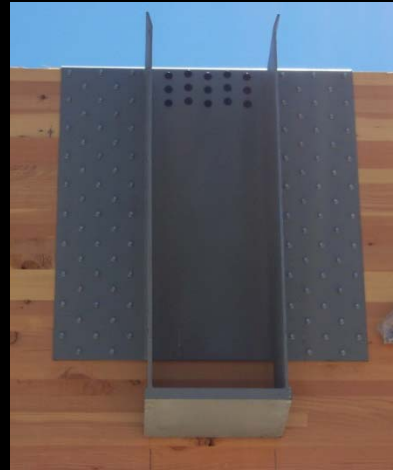
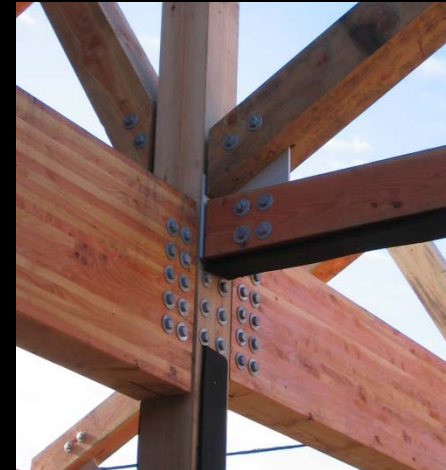
Figure __: Glu laminated timbers in various configurations.

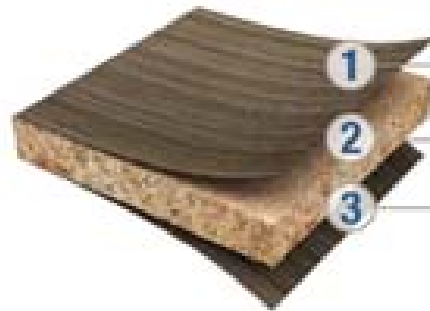
TFL Thermally Fused Laminate

One-step process

Decorative layer available in an array of colors

Particleboard: CARB 2 or NAUF (MDF available)

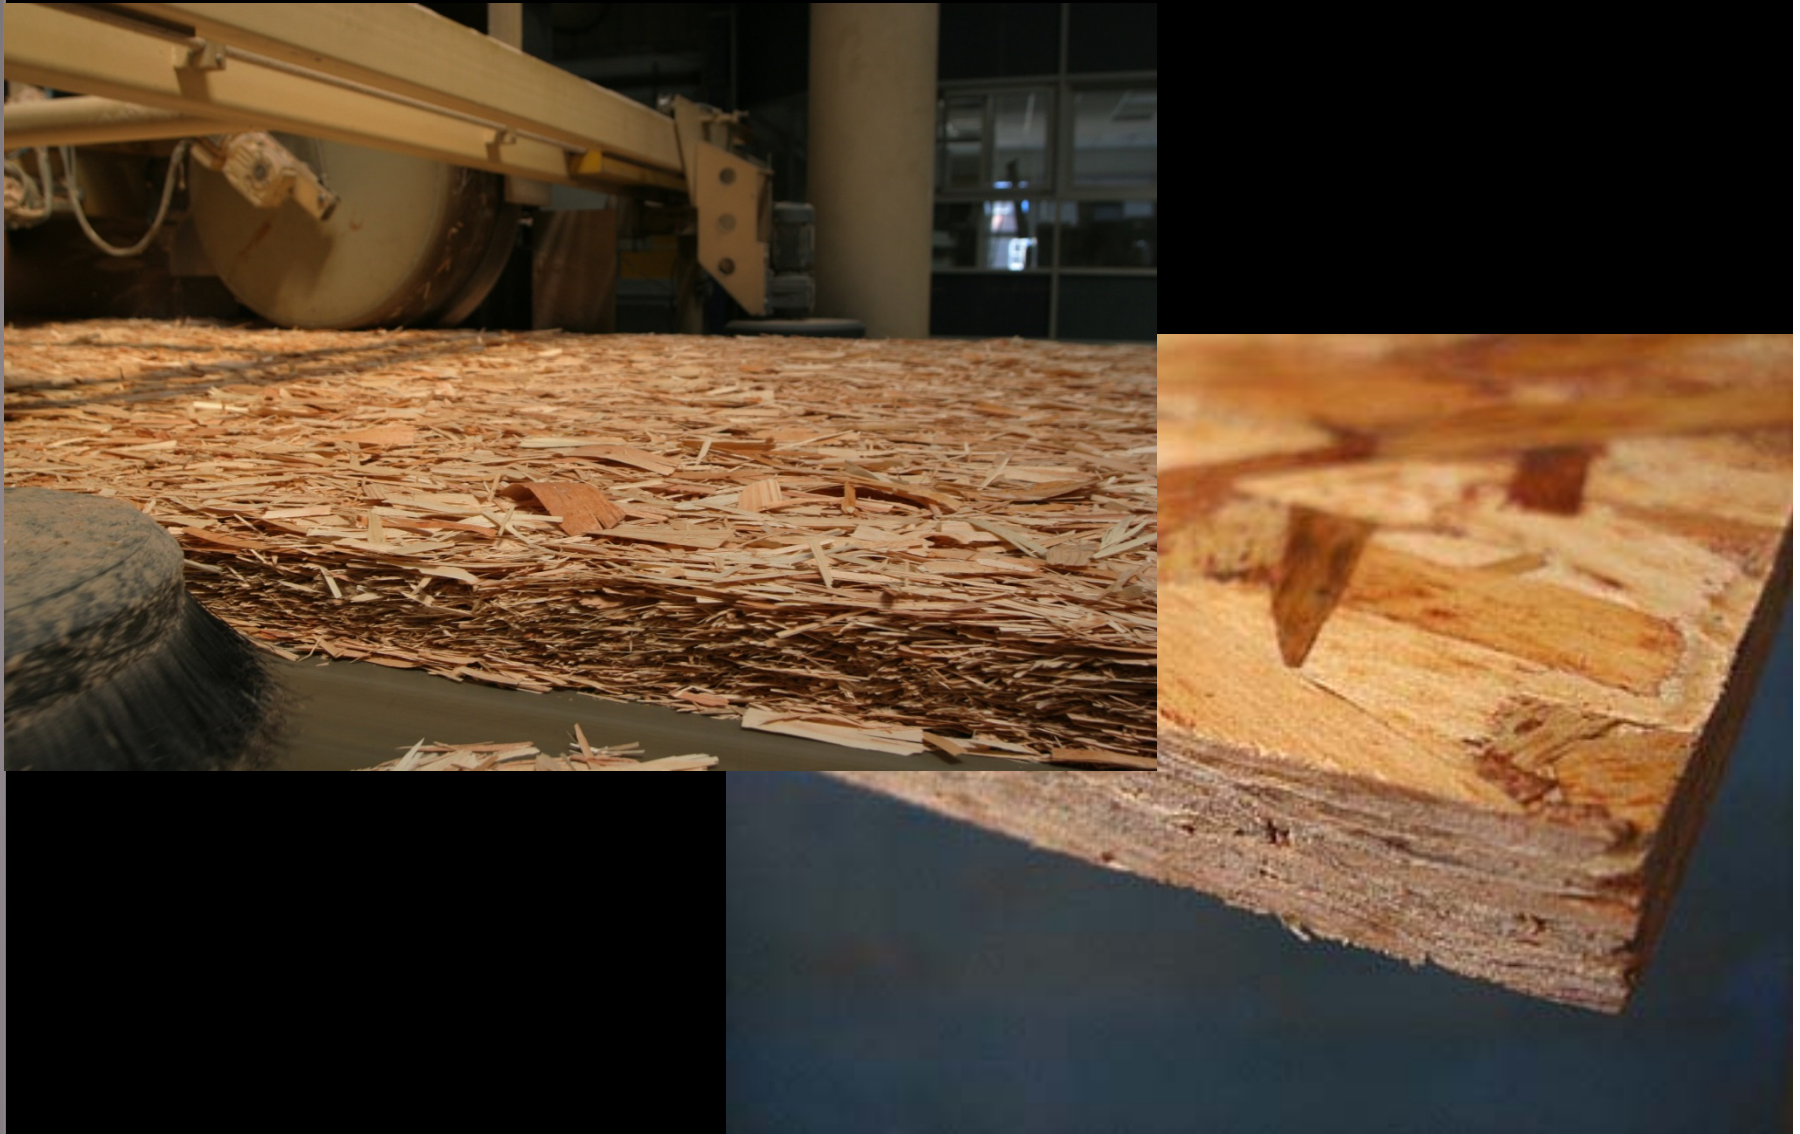
Figure __: The thick pile of carefully sized wood chips is compressed with resin into OSB panels. Credit: wikimedia

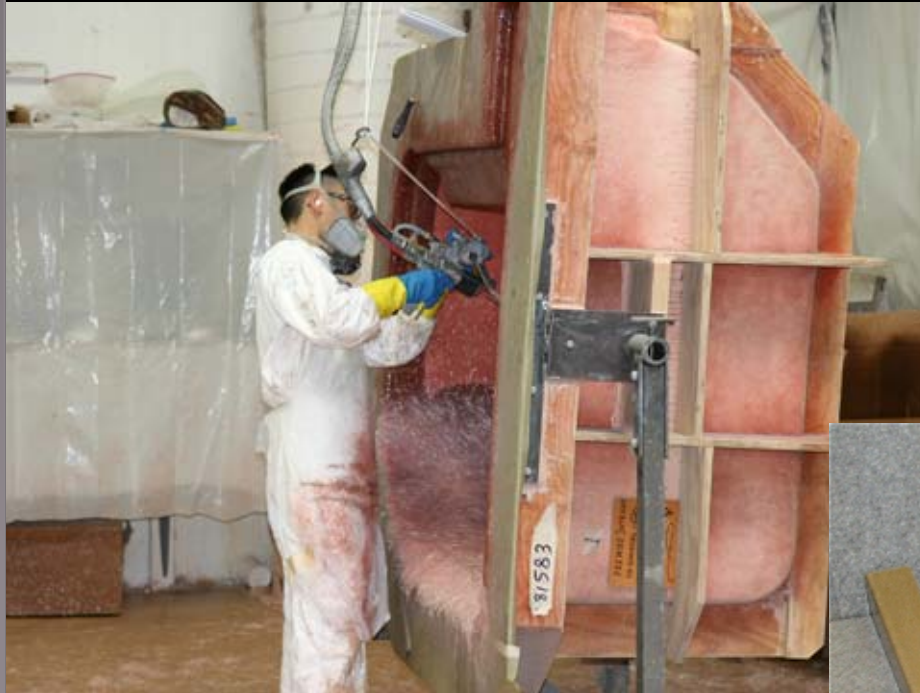
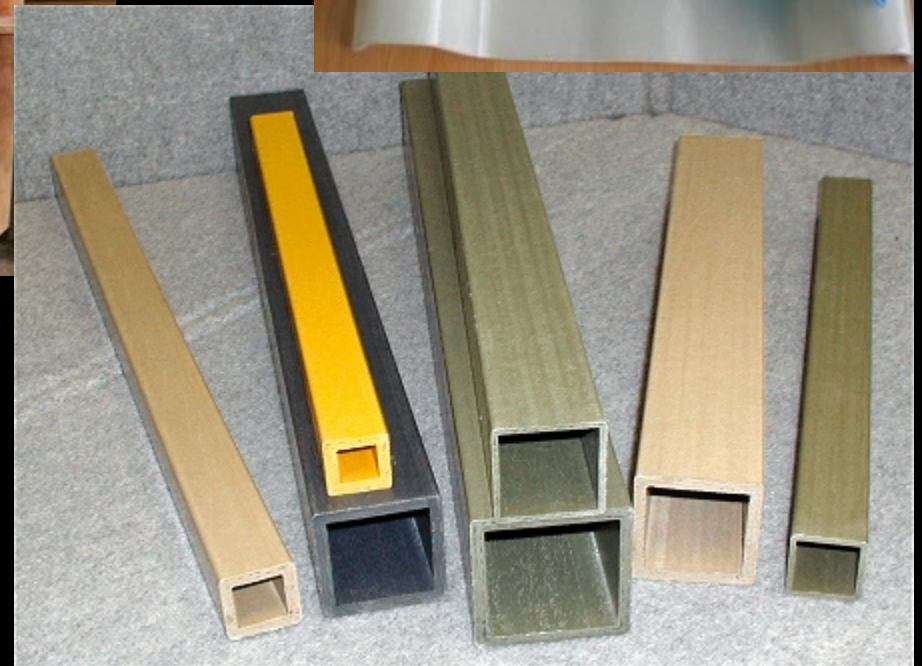
Figure __: Several different forms of fiber reinforced plastic.

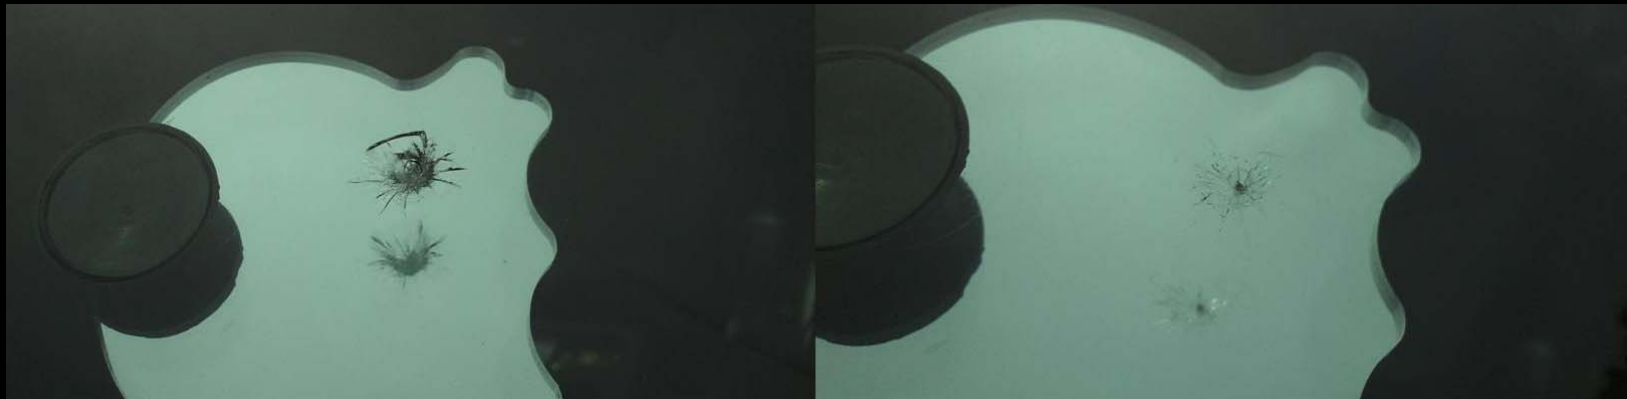
Figure __: Repairing fractured glass can virtually eliminate the apparent damage, but the technology does not have a long history. Credit: mswindshield.com

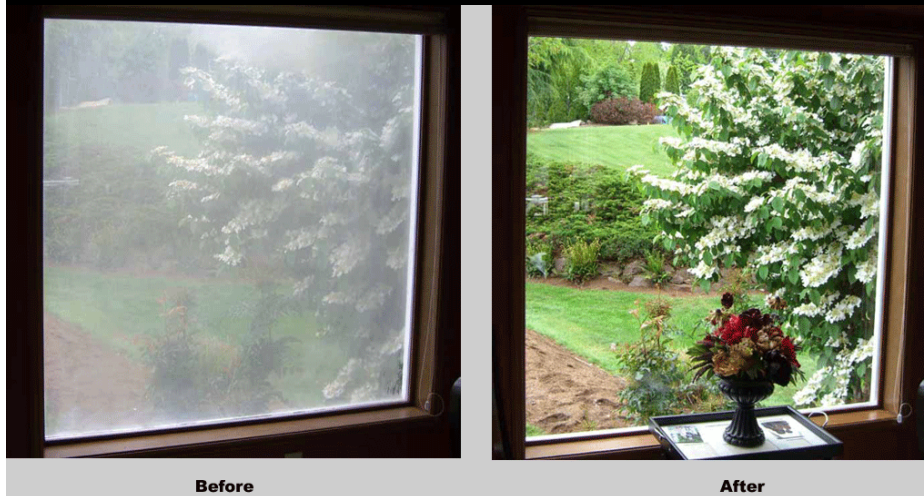
Figure __: The window on the left is an example of a failed insulated glass unit. Credit: lakelandglassmirror.com

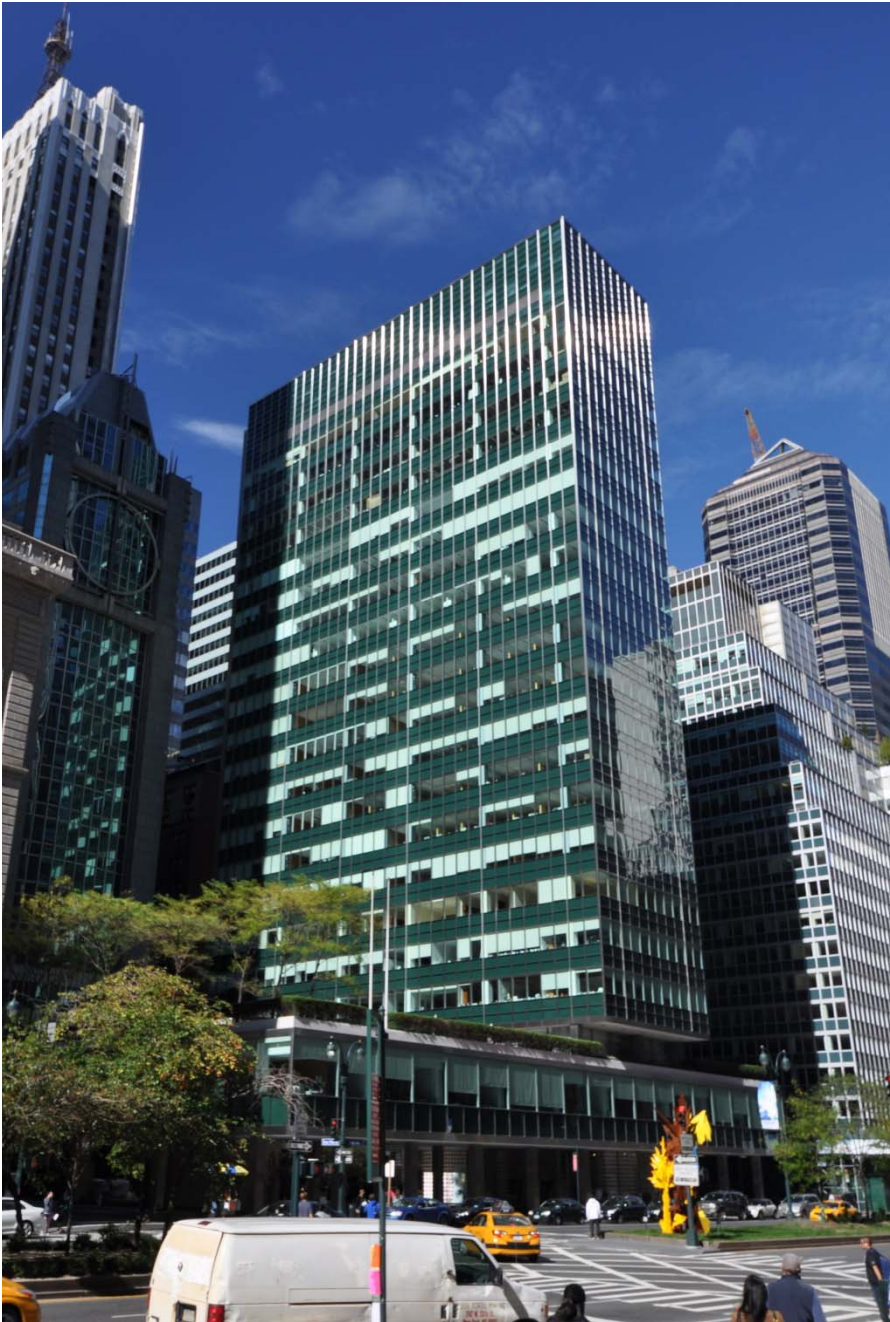
Figure __: The Lever House by Gordon Bunshaft of SOM is one of the earliest aluminum curtainwalls in New York. Credit: Brian Rich, 2013

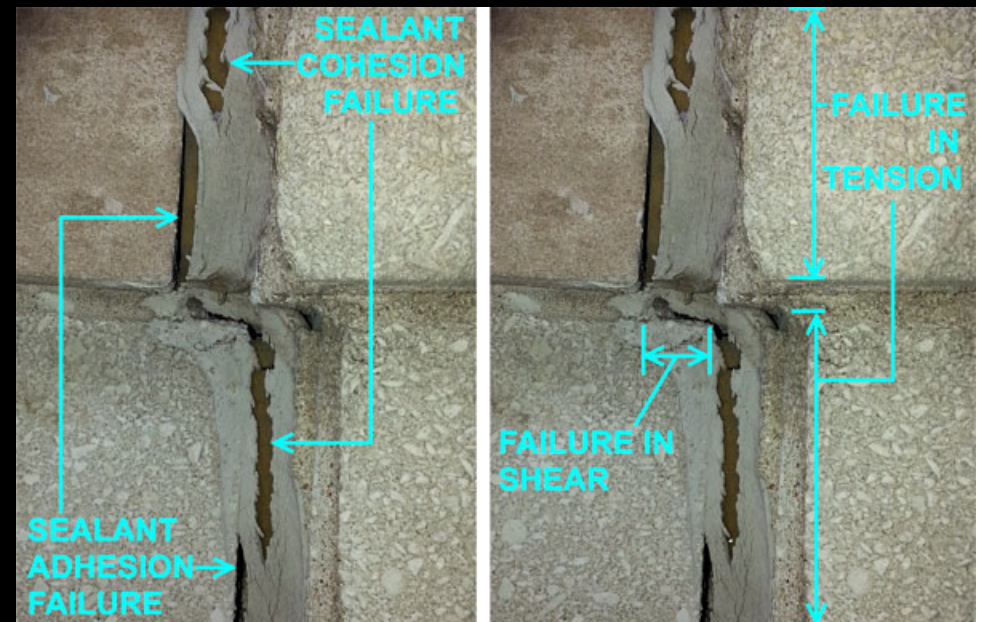
Figure __: Modern sealants fail due to the adhesion to surfaces or internal cohesion of the sealant. Credit: wikimedia

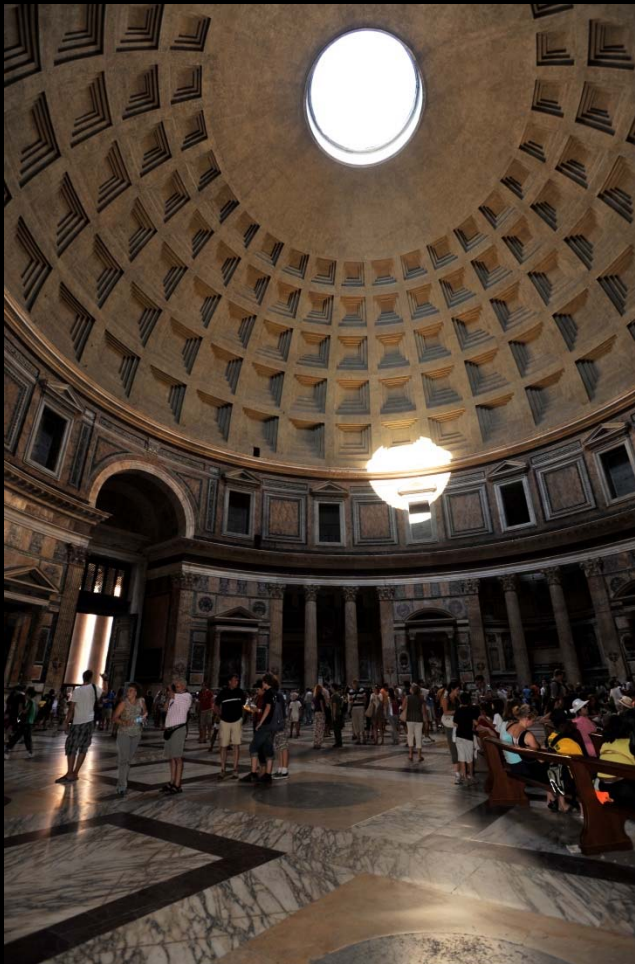
Figure __: The Pantheon in Rome, Italy, circa 128 AD. An unreinforced concrete structure that has endured for centuries. Left: Credit: Emilio Labrador, 2010. Right: credit: Derived from Baukunst Trusker Romer.jpg, modified by cmglee,2012.

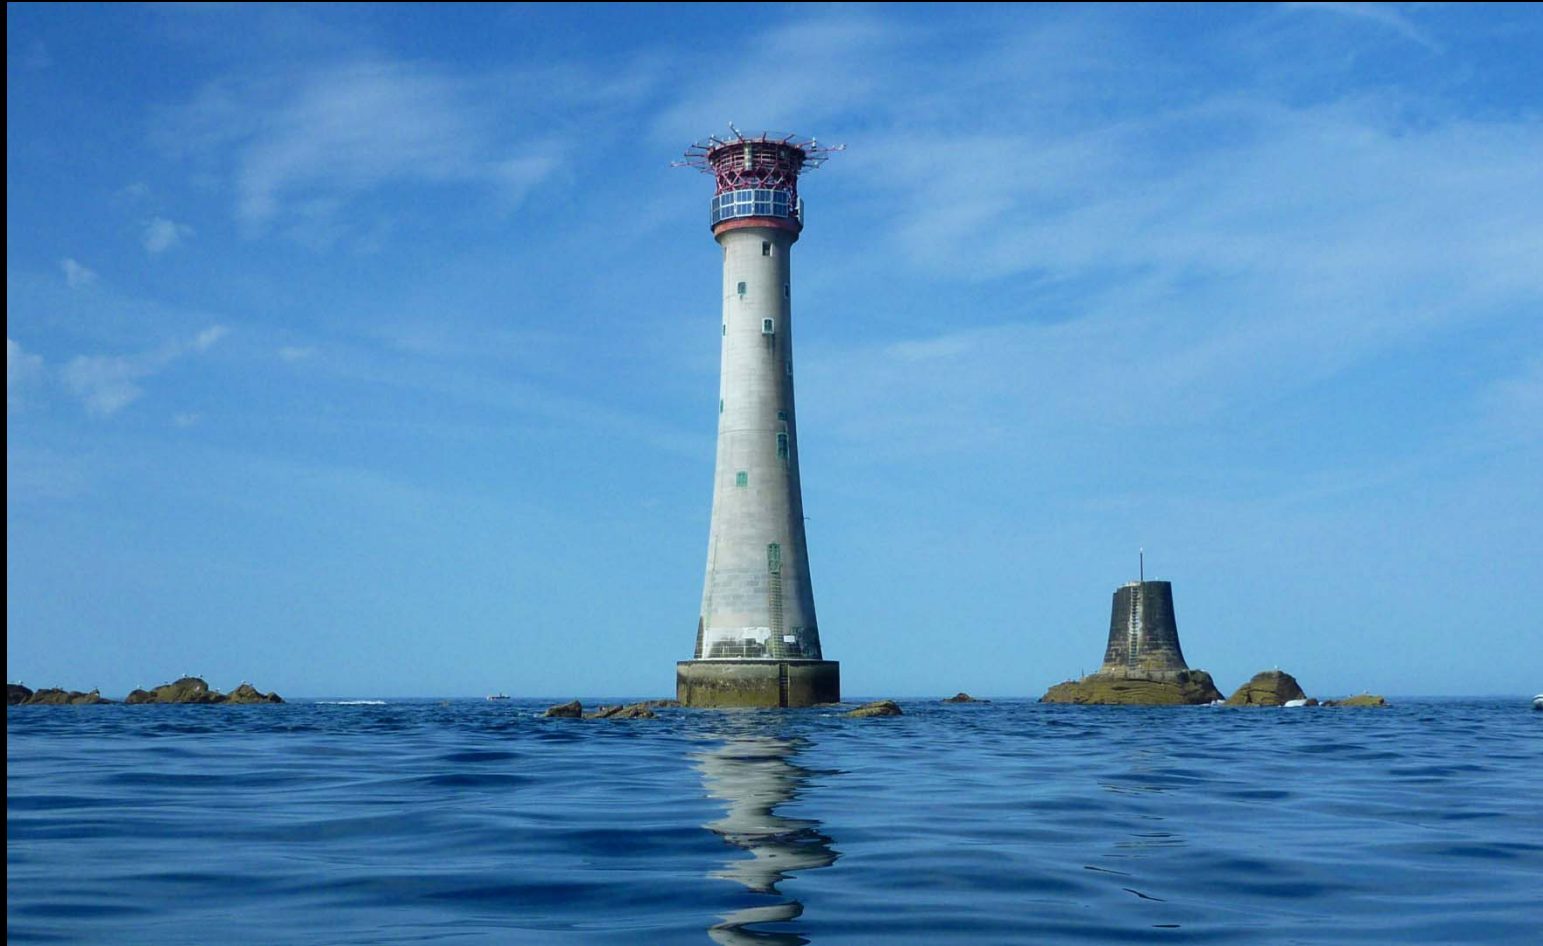
Figure __: The Eddystone Lighthouse, England, 1757. This lighthouse was the result of research by John Smeaton in redeveloping hydraulic cement. Credit: Rupert Kirkwood, 2013.

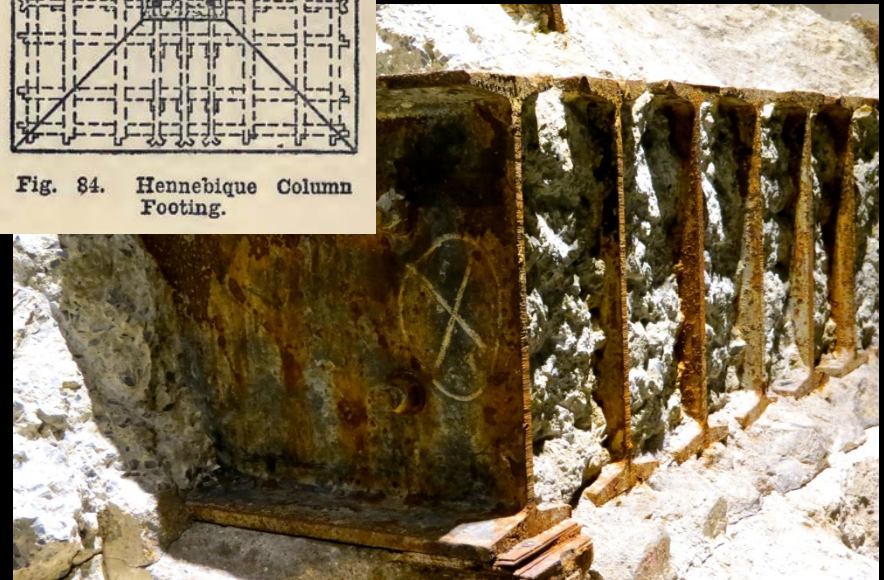
Figure __: Foundations often have crossing layers of steel beams (top left, credit: Hennebique-Radford's cyclopedia of construction, 1909) forming a "grillage," as at the south tower of World Trade Center (bottom right, credit: howdoyoumeasure525600minutes.com, 2001)

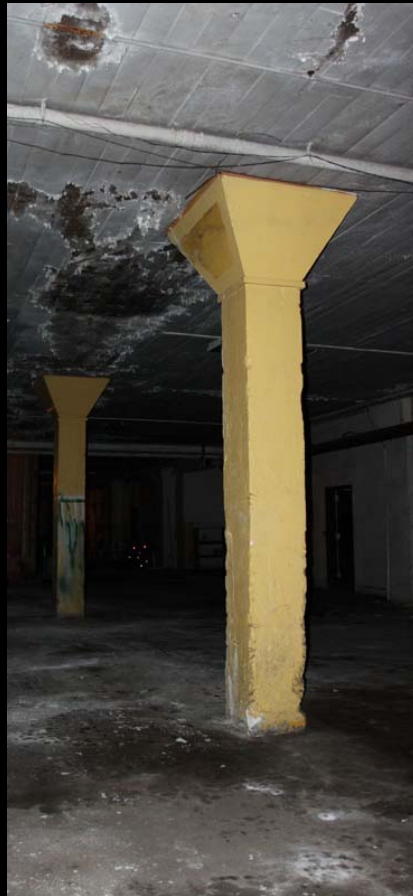
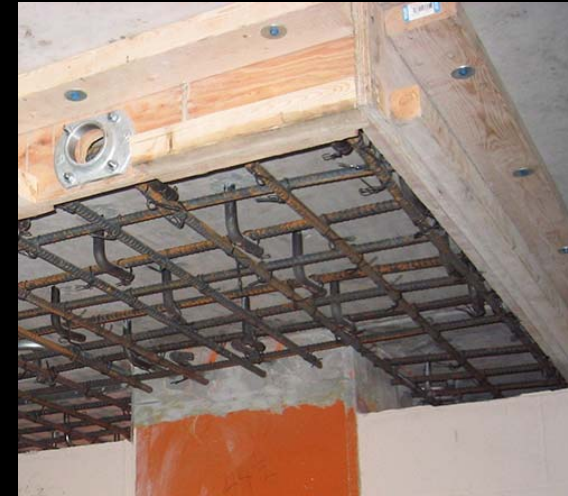
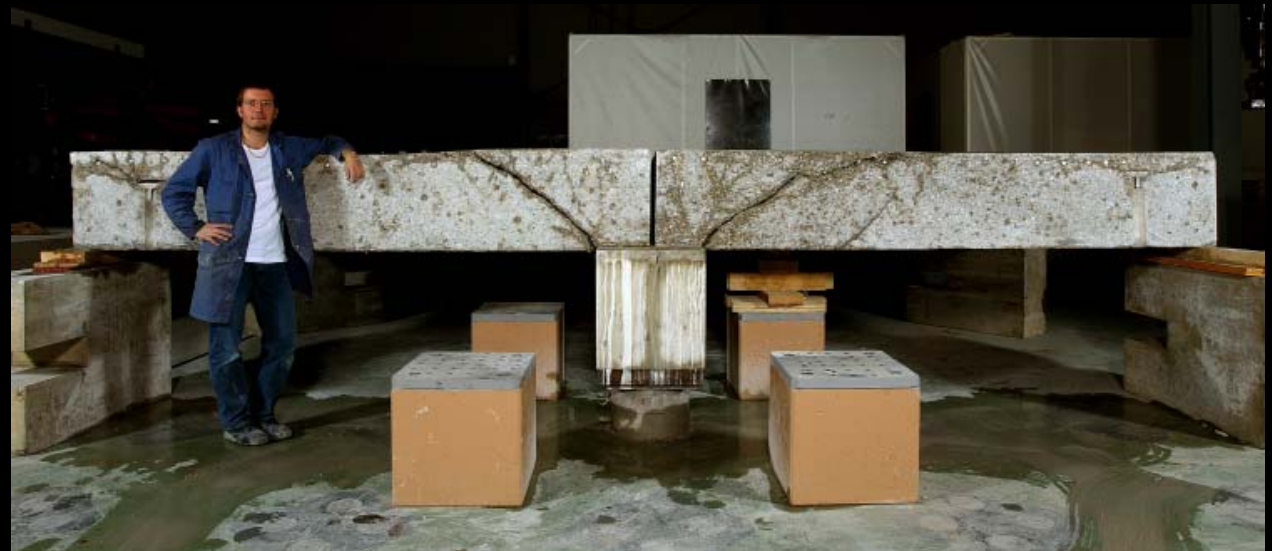
Figure __: Photos showing concrete “punching” on the bottom right (credit: <http://ibeton.epfl.ch/recherche/punching>) and two methods for reinforced concrete to prevent punching shear at column to slab connections. The Duluth MN Armory at the left and a “drop cap” at the right.

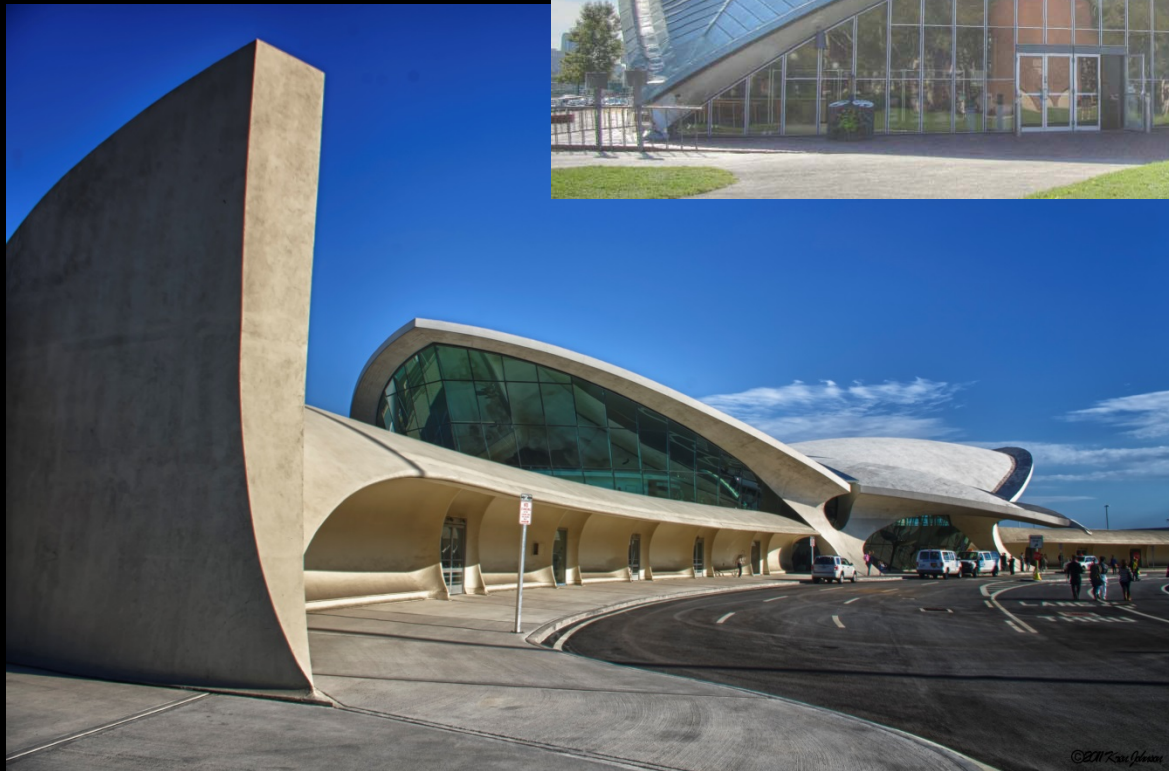
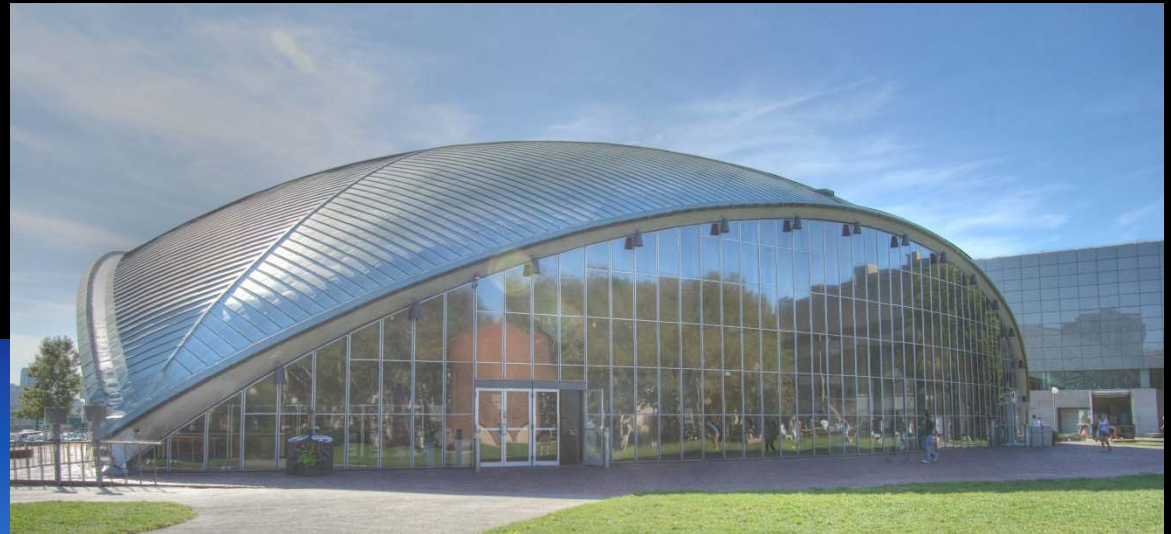
Figure __: Top right: The MIT Kresge Auditorium by Eero Saarinen, 1955 (credit: wikimedia, madcoverboy, 2008.)
Bottom left: The TWA Terminal at JFK Airport, New York, by Eero Saarinen, 1962 (credit: Karen Johnson Photography)

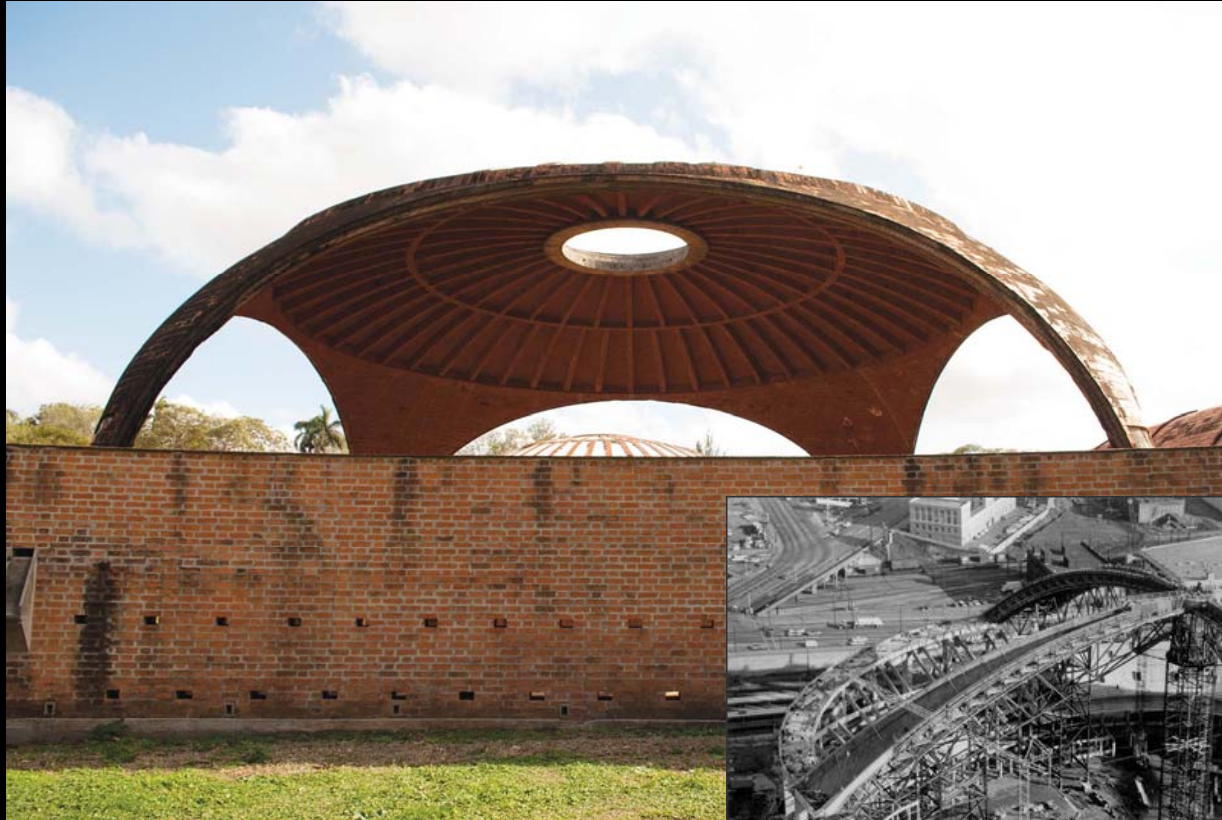
Figure __: Top left: The Cuban School of Ballet by Vittorio Garatti – a Catalan Vault thin shell brick dome (credit: Dieter Janssen, 2015)
 Bottom right: The Kingdome under construction in Seattle, WA, 1974 (credit: Seattle Post Intelligencer, 1974)

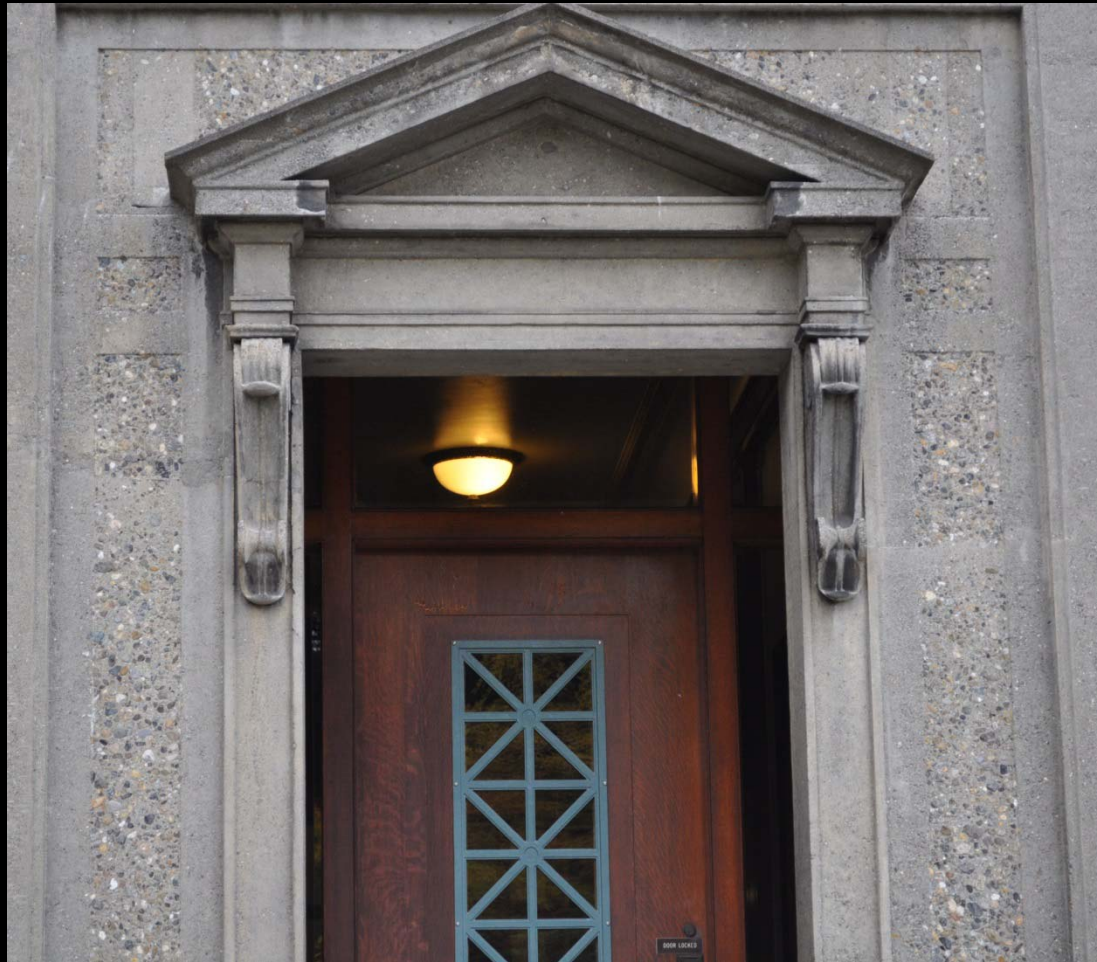
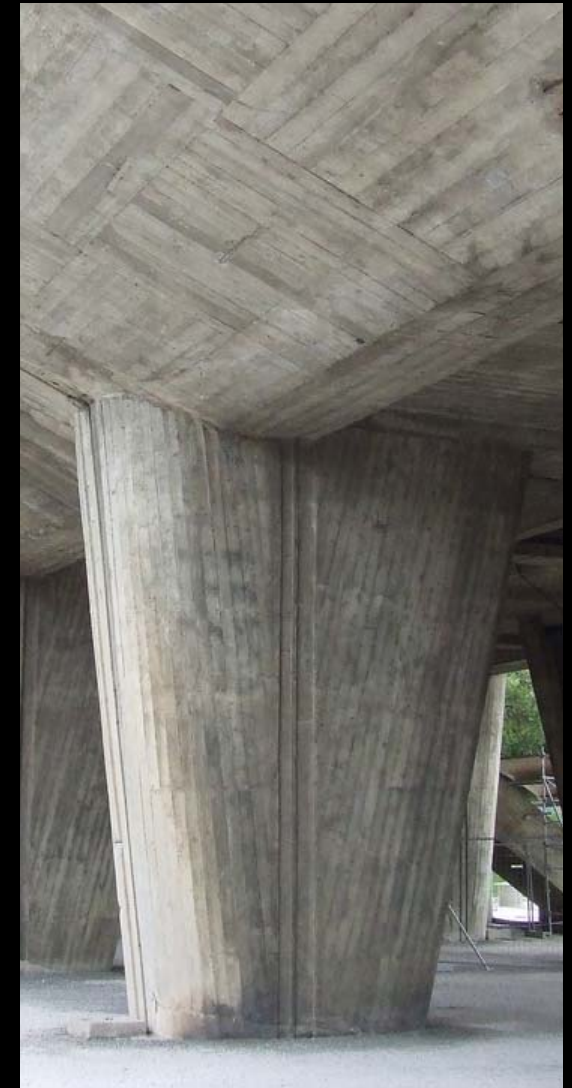
Figure __: Left: The main building at the Ballard Locks with exposed aggregate concrete, 1911-1917. (credit: Brian Rich, 2013)
 Right: Board formed concrete at the Unite D'habitation by LeCorbusier, 1952. (credit: Piere Janerete, 2014)

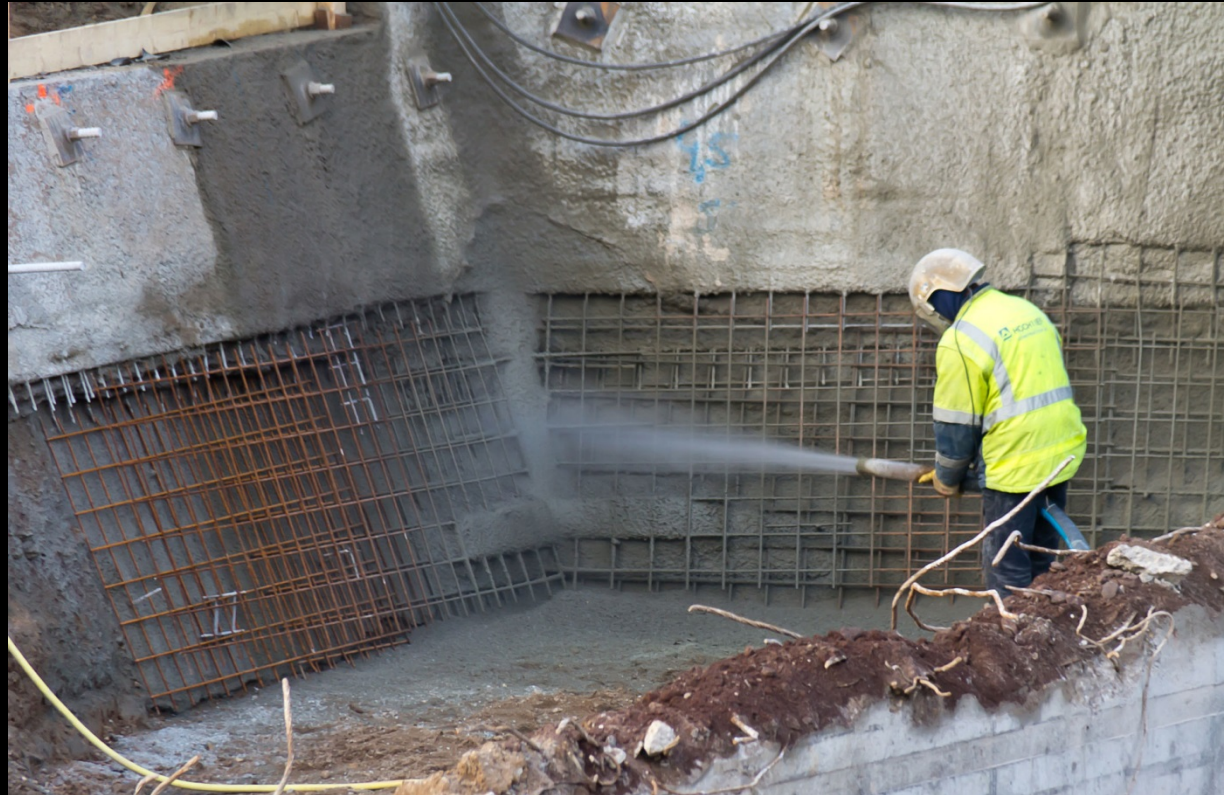
Figure __: Shotcrete (air-blown concrete) being installed as part of a shoring wall. Credit: Raimond Spekking, 2013)

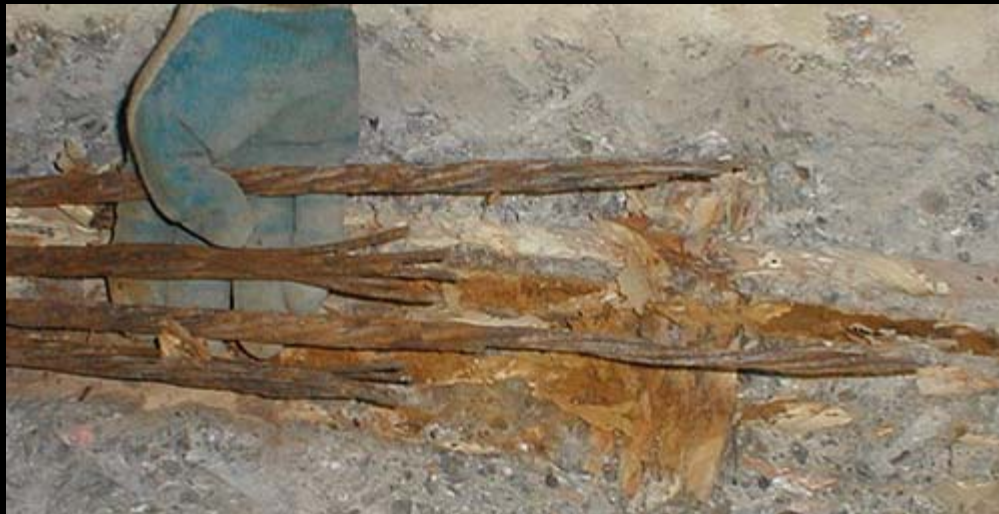
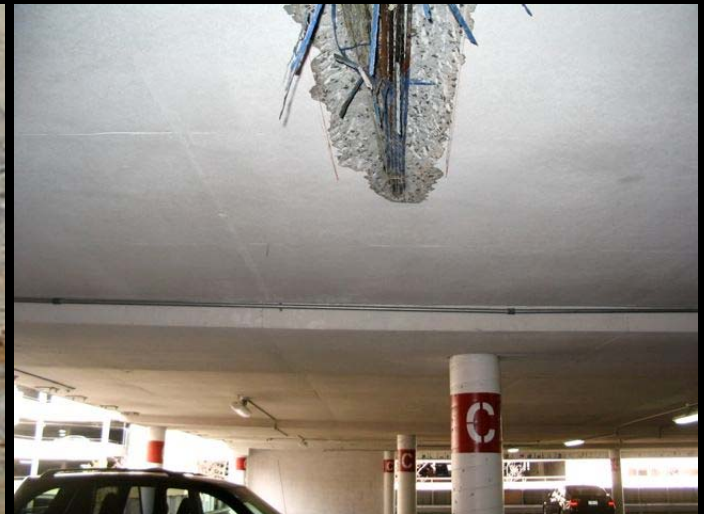
Figure __: Top: Components of a flat duct post-tensioning system (credit: ptsindia.net, 2015). Bottom left: Deteriorating tendons (credit: KJ Rodgers, 2013). Bottom right: Failure of post tensioned tendons can destroy the concrete cover as well (credit: cowleyengineering.com).

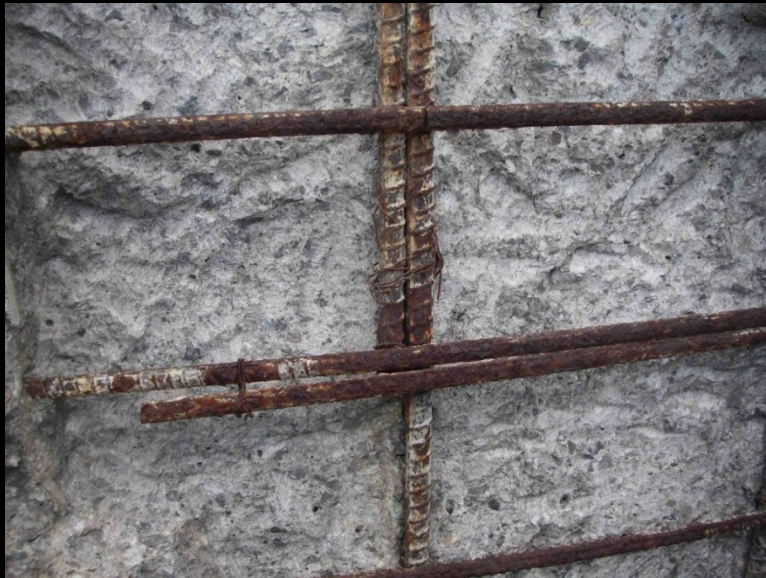
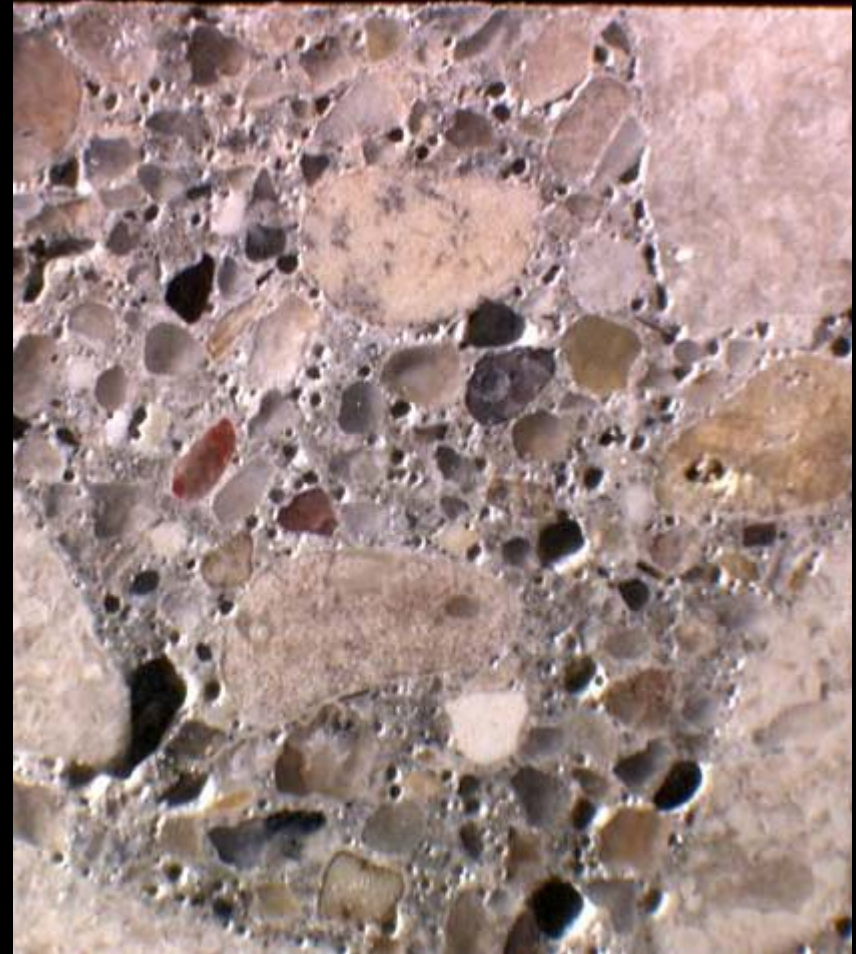
Figure __: Left: Exposed rebar corrodes and loses strength (credit: jenicke.com, 2012)
 Right: Air entrainment voids in concrete make space for water to expand into (credit: nist.gov, 2009)

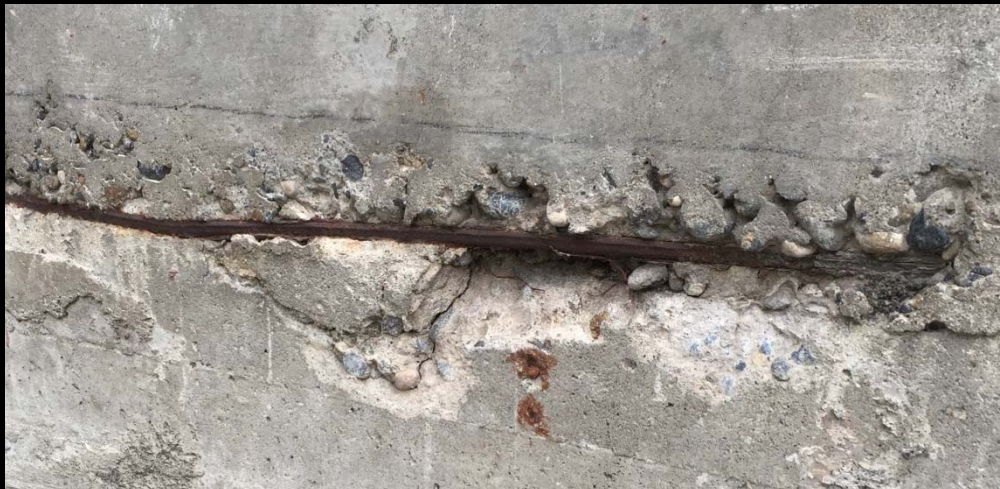
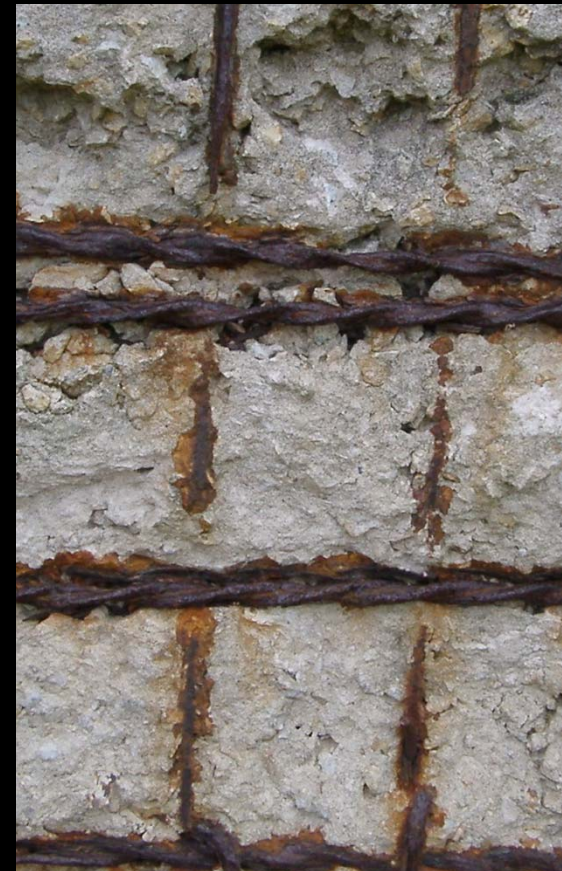
Figure __: Top left: Rebar placed too close to the surface of the concrete at the UW Seattle (credit: Brian Rich, 2014). Bottom left: A diagram of rebar deterioration due to water (credit: Pirro, 2012). Right: Deterioration of rebar placed too close to the surface (credit:).

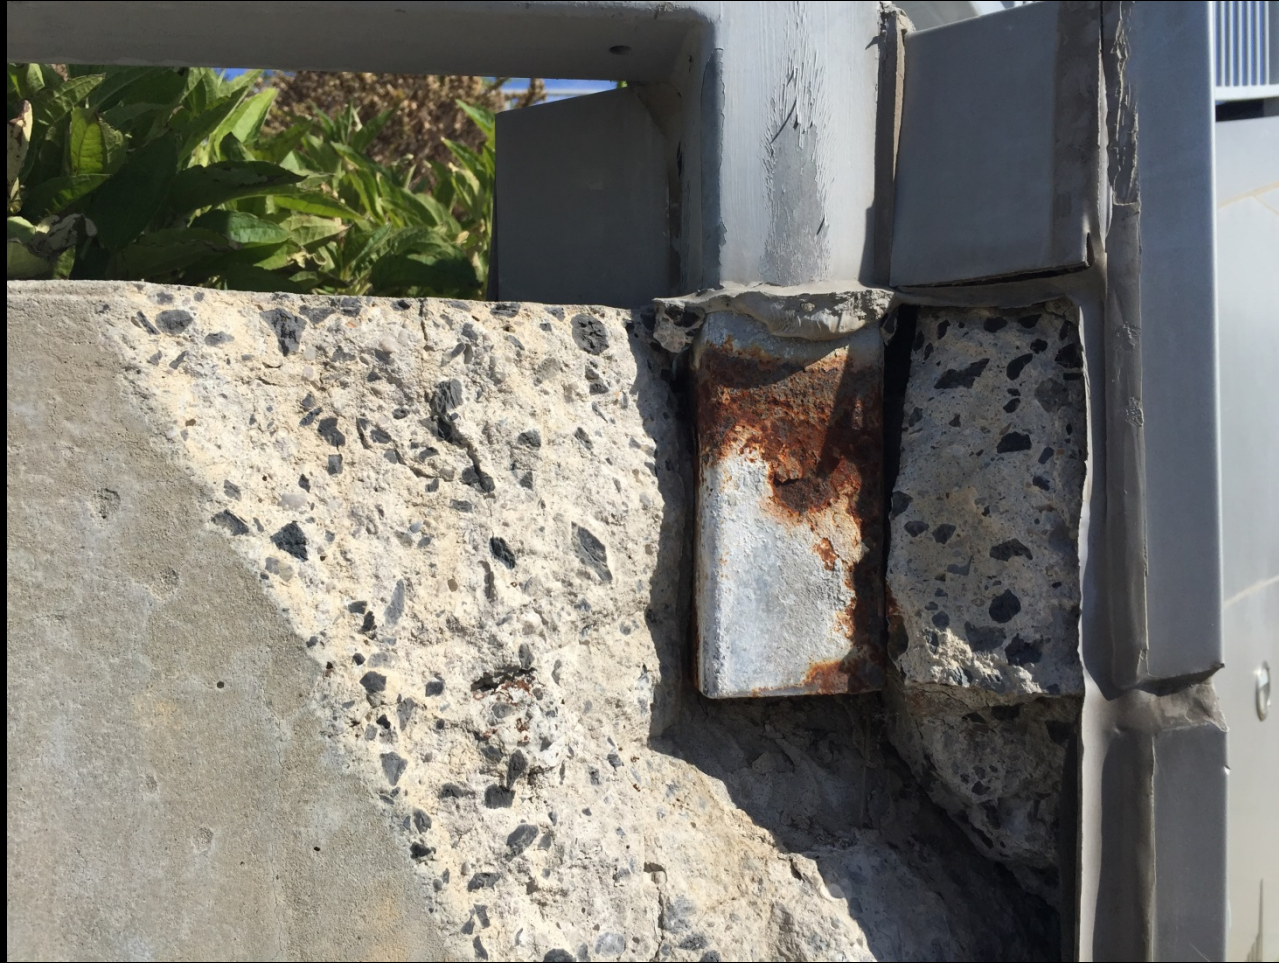
Figure __: Concrete spalling due to freeze-thaw cycles at the Salt Lake City Public Library by Moshe Safdie, 2003. Credit: Brian Rich, 2015.
