Preservation of Modern Materials

27 April 2016

Brian Rich
APT_{NW} President

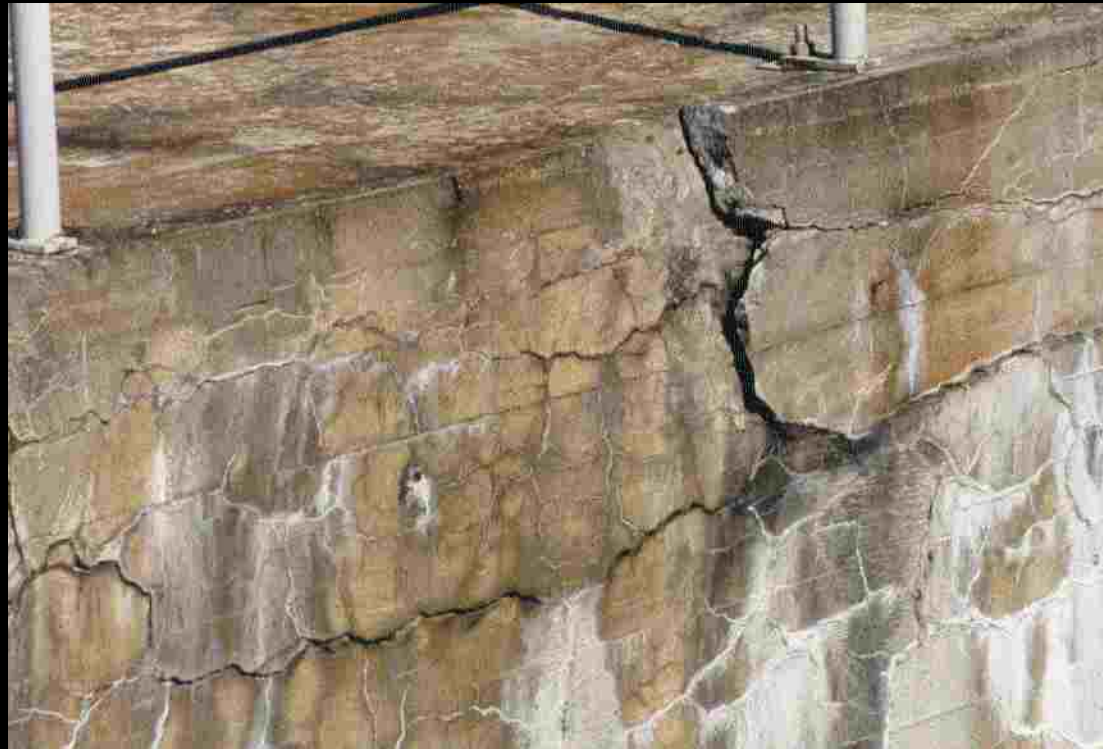
Figure __: Concrete spalling due to an Alkali-Aggregate Reaction. Petrographic microscope or scanning electron microscope imaging can be used to confirm the formation of a gel due to this chemical process. Credit: Viggo Jensen, NBTL, 2003.

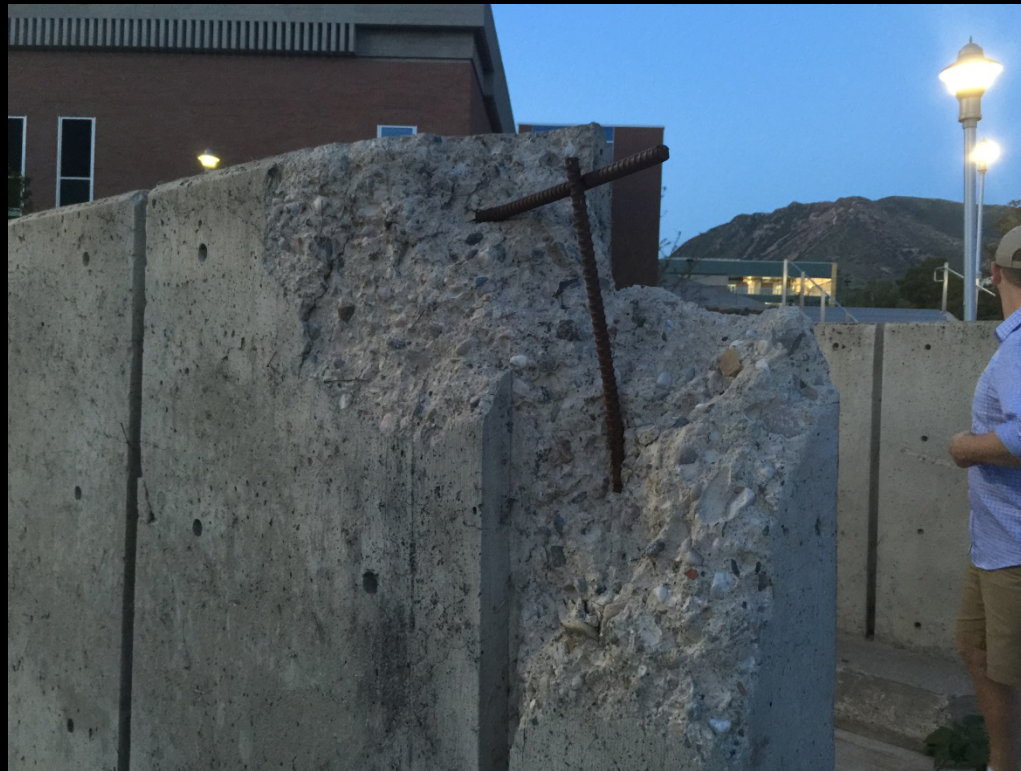
Figure __: Concrete deterioration at a concrete wall at the University of Utah, Salt Lake City, Utah. Credit: Brian Rich, 2015

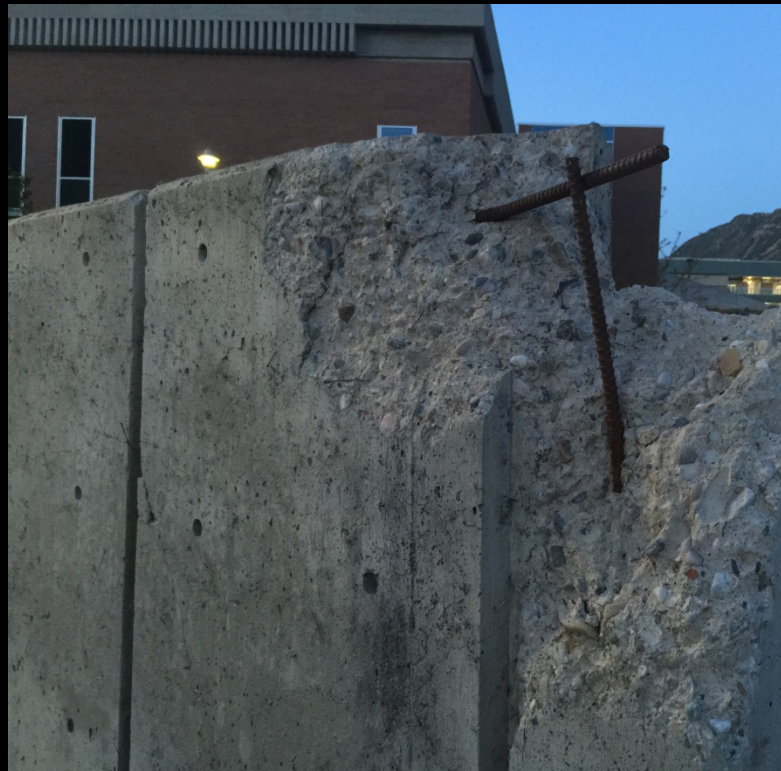
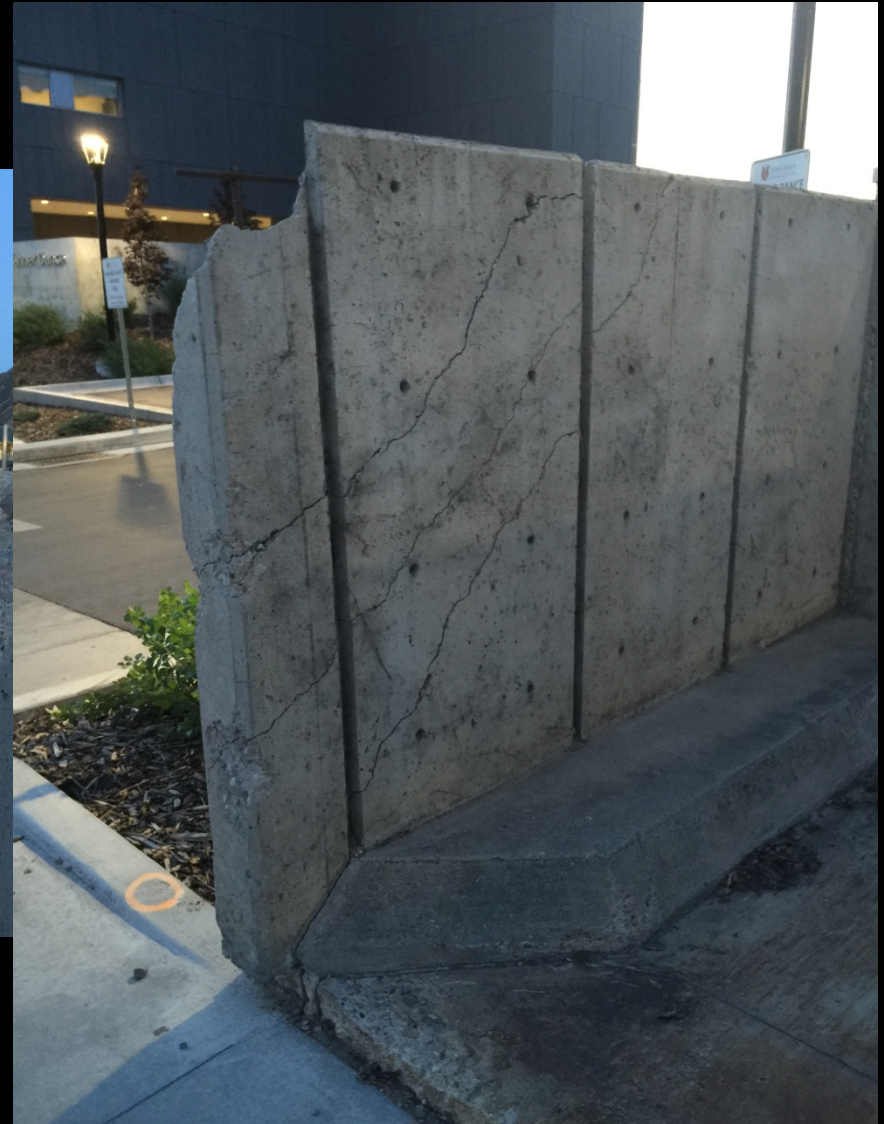
Figure __: Concrete deterioration isn't just chemical or corrosion based. It can also be mechanical, such as this damage by a garbage truck that ran into the concrete wall. Credit: Brian Rich, 2015.

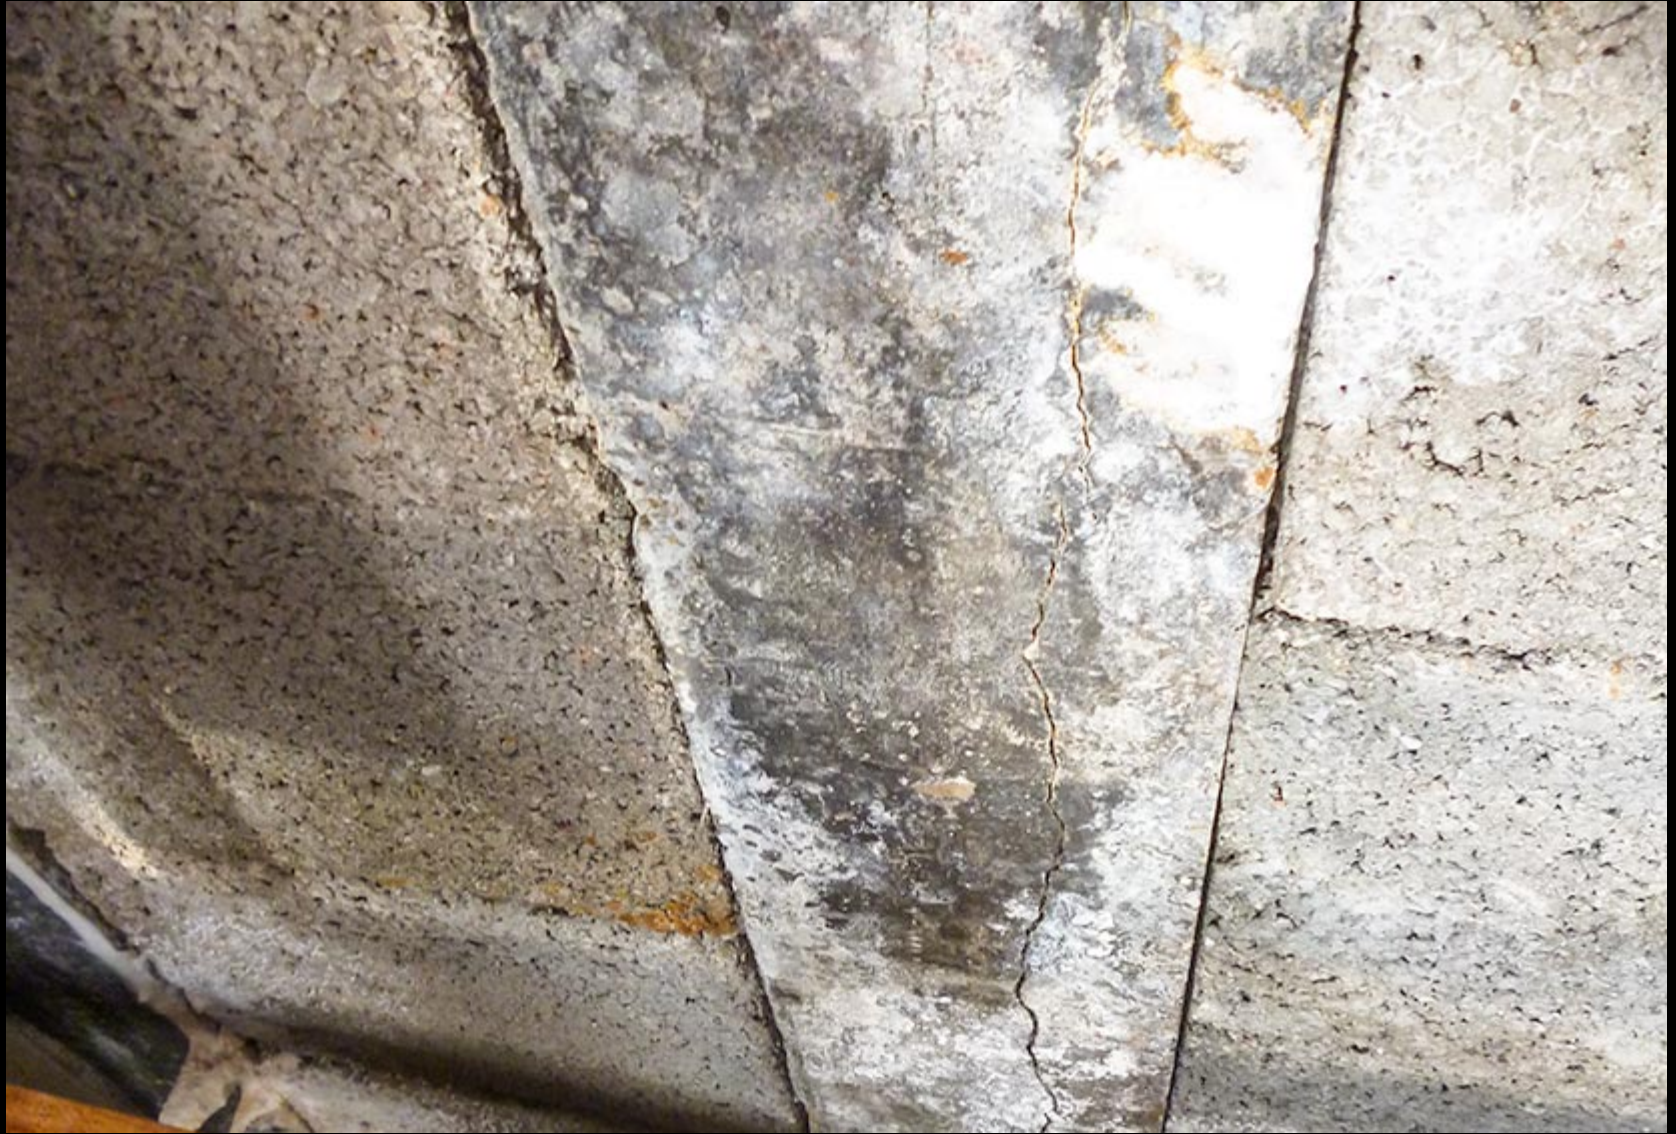
Figure __: High alumina cement deterioration is caused by reactions of the alumina to other components of the concrete leaving voids that become structurally weak points in this concrete joist. Credit: www.sandberg.co.uk, 2014

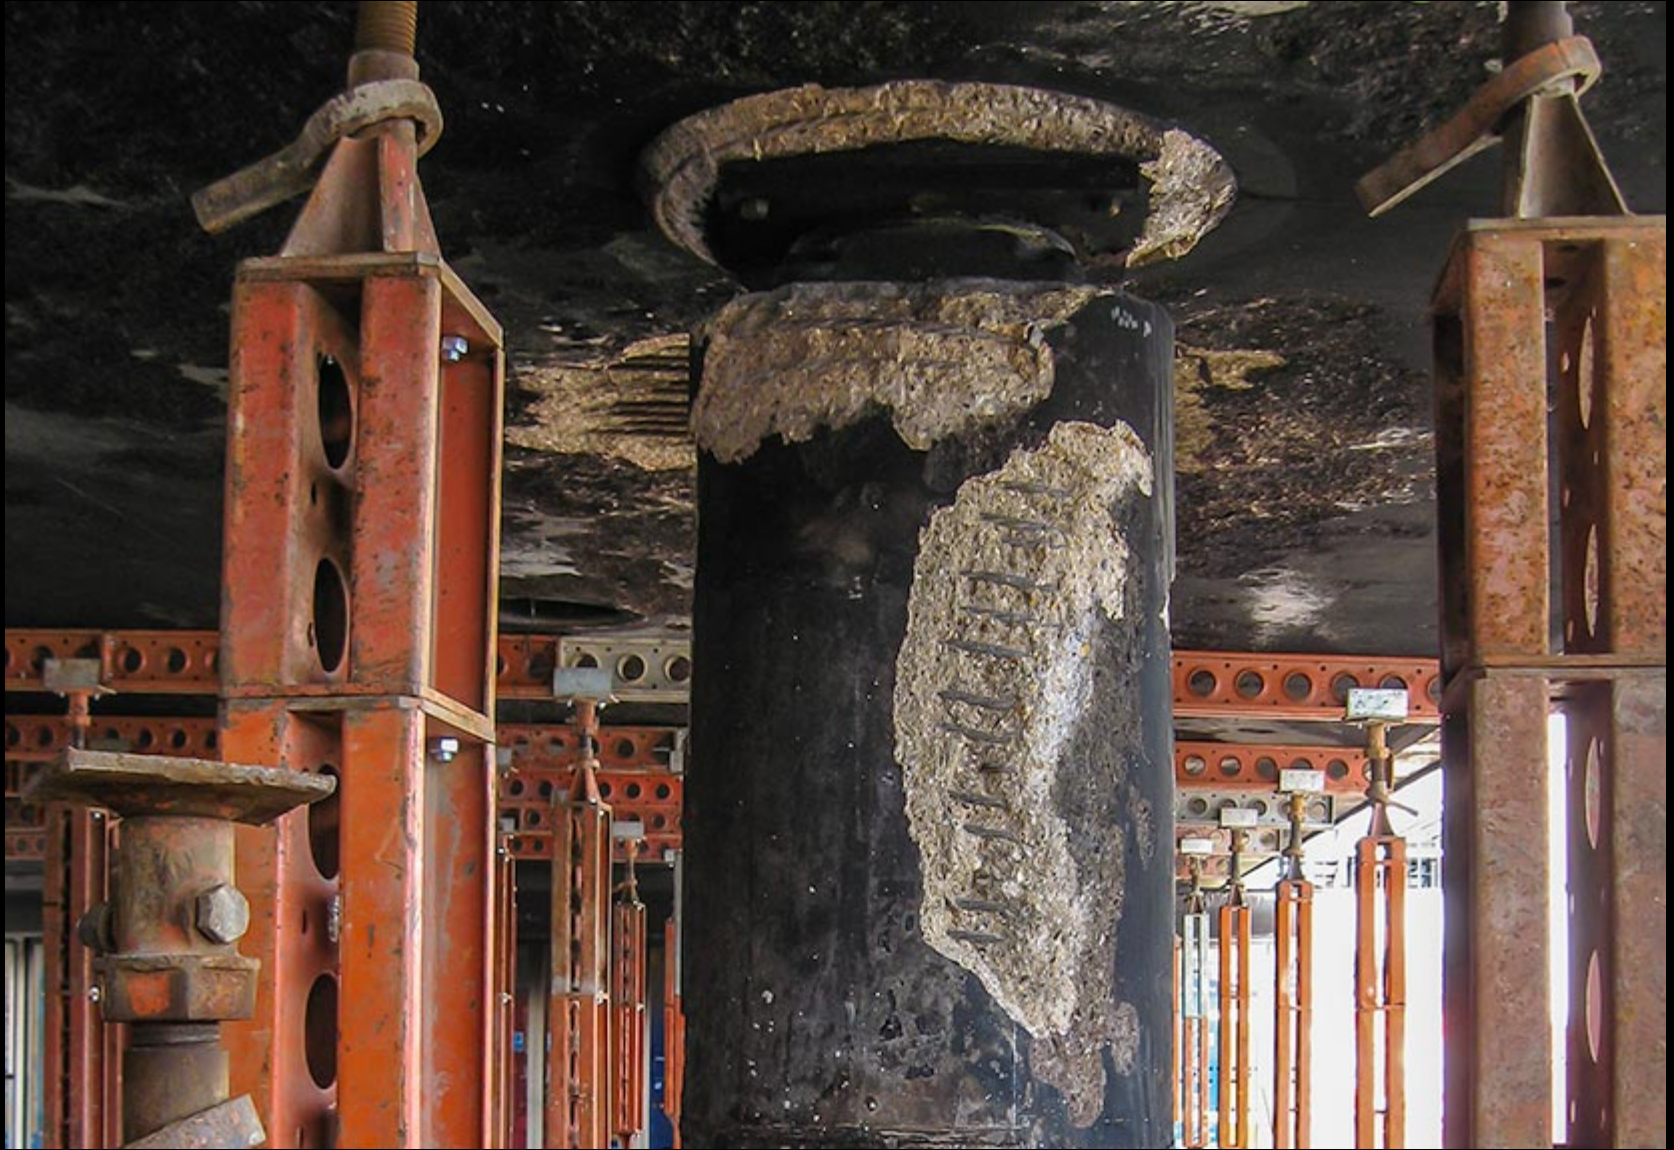
Figure __: Fire damaged concrete can spall, exposing rebar to corrosion and even melting rebar in sustained fires. Credit: www.sandberg.co.uk, 2014
