# PRESERVATION EDUCATION & RESEARCH

VOLUME 7 | 2014

# THE PRINCIPLES OF FUTURE-PROOFING: A BROADER UNDERSTANDING OF RESILIENCY IN THE HISTORIC BUILT ENVIRONMENT

BRIAN D. RICH

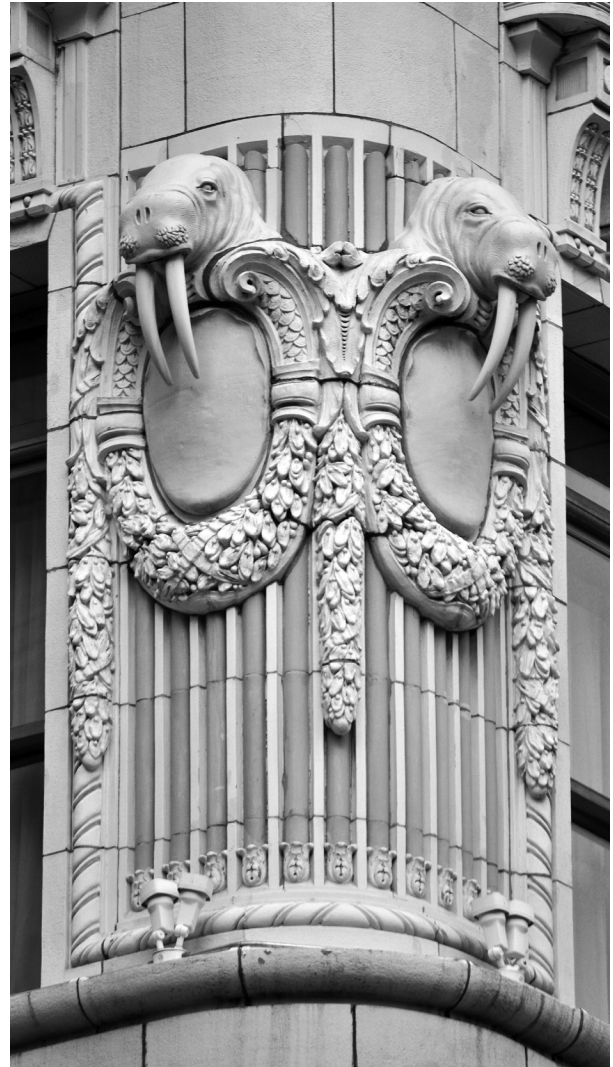
*Fig. 1. The double walrus heads at the southwest corner of the Arctic Building in Seattle, Washington. Note the highly decorative terra cotta, bright colorful palette, and the tusks that hang from the walrus heads. (Credit: Brian Rich, 2013.)*

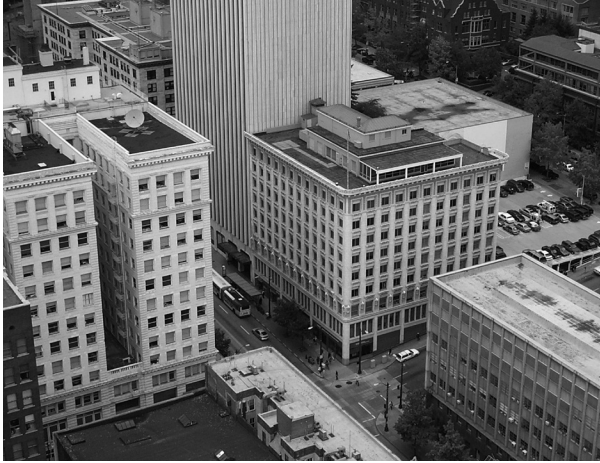
Fig. 2. Aerial photo of the Arctic Building from the south-west. (Credit: City of Seattle Archives, SPU Fleets and Facilities Department. Imagebank Collection. Item No: 120399.)

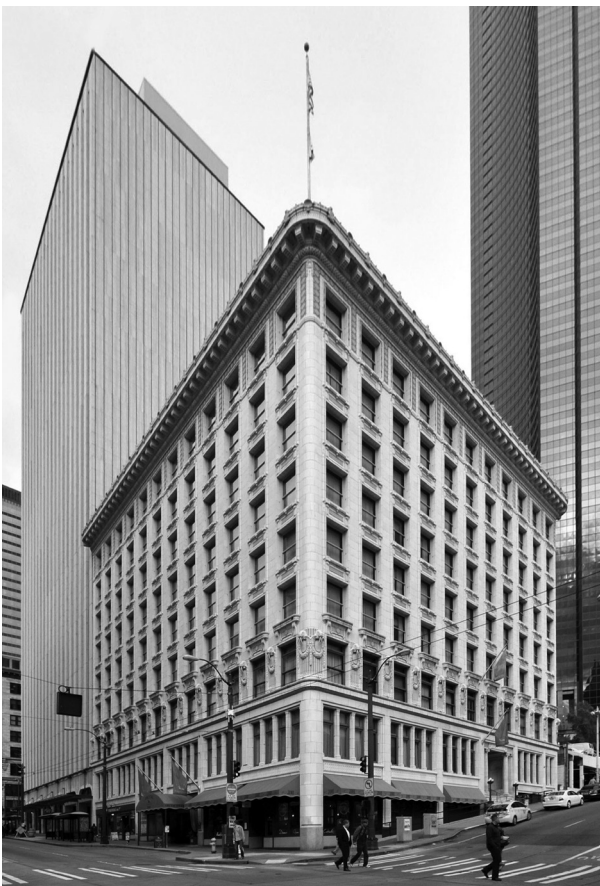
Fig. 3. View of the exterior of the Arctic Building from the intersection of Third Avenue and Cherry Street. The walrus heads adorn the third floor. (Credit: Brian Rich, 2013.)

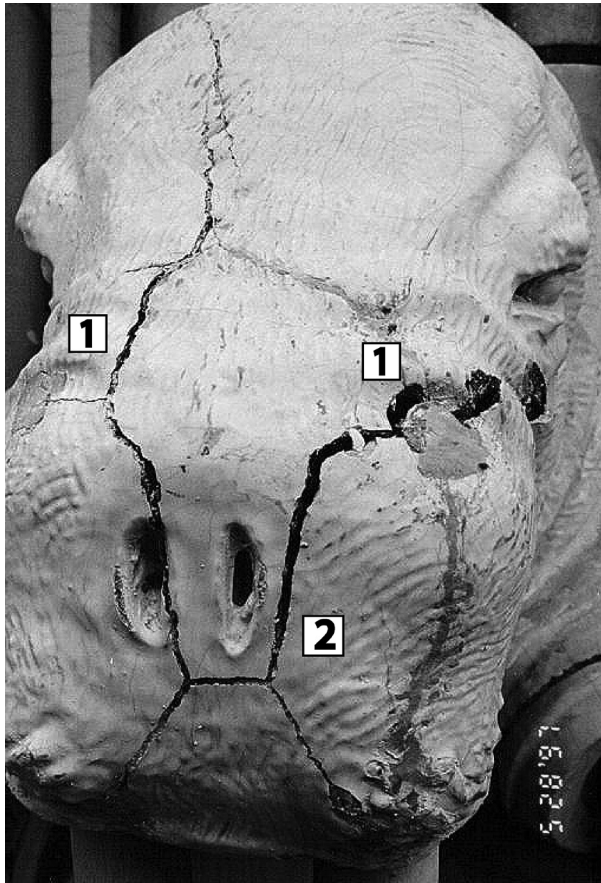
Fig. 5. Existing conditions in late 1995. Note the dark spots above the nostrils to the right and left (1). These are the holes grout was filled through. Note that they are on top of the walrus head. Also note the cracking of the snout (2). (Credit: Wiss, Janney, Elstner Associates, Inc.)

In late 1995, a condition survey and investigation of the walrus heads was performed by Wiss Janney Elstner (Morden and Slaton 1996). Overall, the building was determined to be in “good condition,” but the walrus heads were a different story. The degradation of the walrus heads had progressed to the point where the ornamental terra cotta units were wrapped with chicken wire and duct tape to hold the pieces together until repairs could be made (Morden and Slaton 1996, 1). A field survey of the walrus heads found many modes of deterioration present. Fractures, spalling, cracks, crazing, and rust jacking (expansive corrosion of ferrous metals) were observed. The investigation discovered that the holes for the 1982 grout injection were located at the top surfaces of the walrus heads rather than on the vertical surfaces as detailed in the repair plan (Figures 5, 6, and 7). The 1995 investigations also discovered that the fiberglass masks had not been installed (Morden 2013).

On-site observations of the locations of the cracks in the walrus heads provided important clues about the deterioration. The cracks were located around the grout injection holes and the voids in the terra cotta where the grout had been injected (Morden 2013; Morden and Slaton 1996, 6).

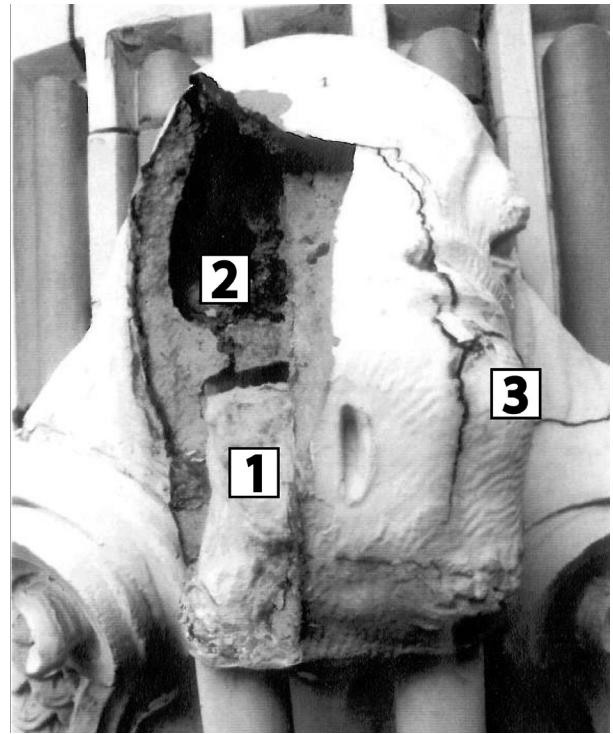
Fig. 6. 1996 inspection photo of walrus head S-1. Note the white grout sections filling the sinus cavity area of the walrus head (1). This meant there was no space left for the grout to expand into when the gypsum got wet. Note also the crack in the internal webbing (2). The damage to the internal structure of the head was so severe that this head had to be replaced. Note the cracks radiating from the dot on the top right of the walrus snout (3). This dot is the injection point for the 1982 grout installation and created a weak point in the terra cotta. (Credit: Morden & Slaton, WJE.)

The location of the grout injection holes is a likely contributor to the deterioration of the walrus heads. Water likely penetrated the terra cotta units and the grout infill within the walrus heads through the grout injection holes in addition to existing mortar joints, cracks, and spalls in the glazing (Morden and Slaton 1996, 6). The location of the grout injection holes may have made this water infiltration worse because they were located on top of the walrus heads. In addition, however, the hole location also allowed the grout to fill the entire terra cotta cavity, leaving the grout no place to expand.

Material samples of the grout that held the walrus tusks were taken and confirmed a high percentage of gypsum in the grout. A material analysis found that the grout consisted of 32 percent deleterious sulfate compounds. These compounds were in the form of gypsum (calcium sulfate hydrate) and ettringite (calcium sulfoaluminate hydrate) (Backus 1996). In this instance, because of the full cavities, there was no place to relieve the pressure from the ettringite formation.

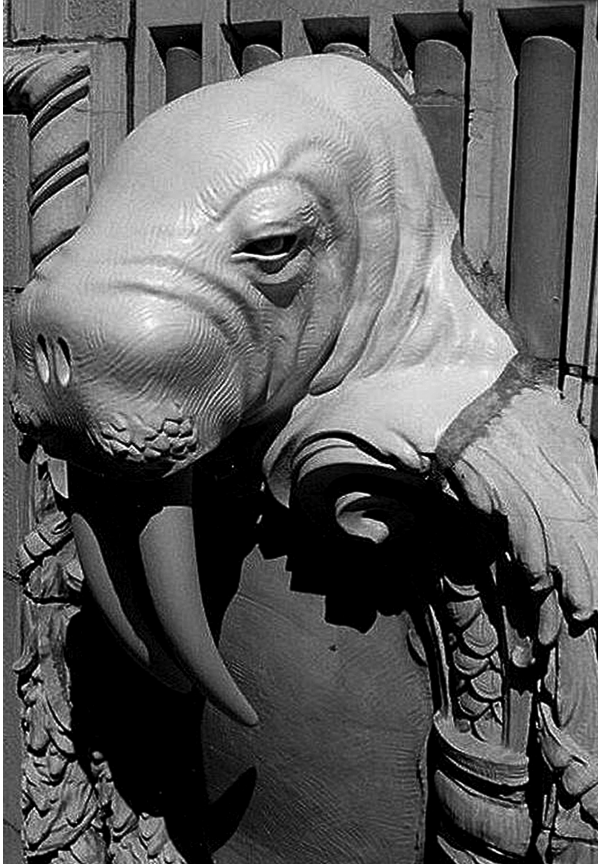
*Fig. 8. 1996 replica walrus head. The joints between terra cotta pieces are filled with mortar after the epoxy sets around the threaded rod anchors. (Credit: Wiss, Janney, Elstner Associates, Inc.)*

and replacement pieces were recommended. A total of twelve walrus heads were replaced after two were later found to be too severely damaged to be repaired. Alternative materials for replication were considered, but since the cost was approximately the same, terra cotta was preferred in accordance with the Secretary of the Interior's Standards for Rehabilitation (Morden 2013). All of the urethane tusks had been salvaged and were reinstalled in the new heads by bolting them through the new terra cotta. No grout was used to install the tusks (Morden 2013).

A variety of repairs were planned for the remaining fifteen of the twenty-seven walrus heads. Where structural integrity was believed to be acceptable, the walrus heads were repaired. Additional helical anchors were provided for seven walrus heads where sections of terra cotta were beginning to delaminate. Where possible, cracks were cut out to a width and depth suitable for grout infill (Figure 8). The 1982 gypsum-Portland cement grout was
